**DAMAGE AND CRACKING OF  
EMBANKMENT DAMS BY EARTHQUAKES  
AND THE IMPLICATIONS FOR  
INTERNAL EROSION AND PIPING**

STEVEN PELLIS AND ROBIN FELL

UNICIV REPORT No. R-408 JANUARY 2002  
THE UNIVERSITY OF NEW SOUTH WALES  
SYDNEY 2052 AUSTRALIA  
<http://www.civeng.unsw.edu.au>

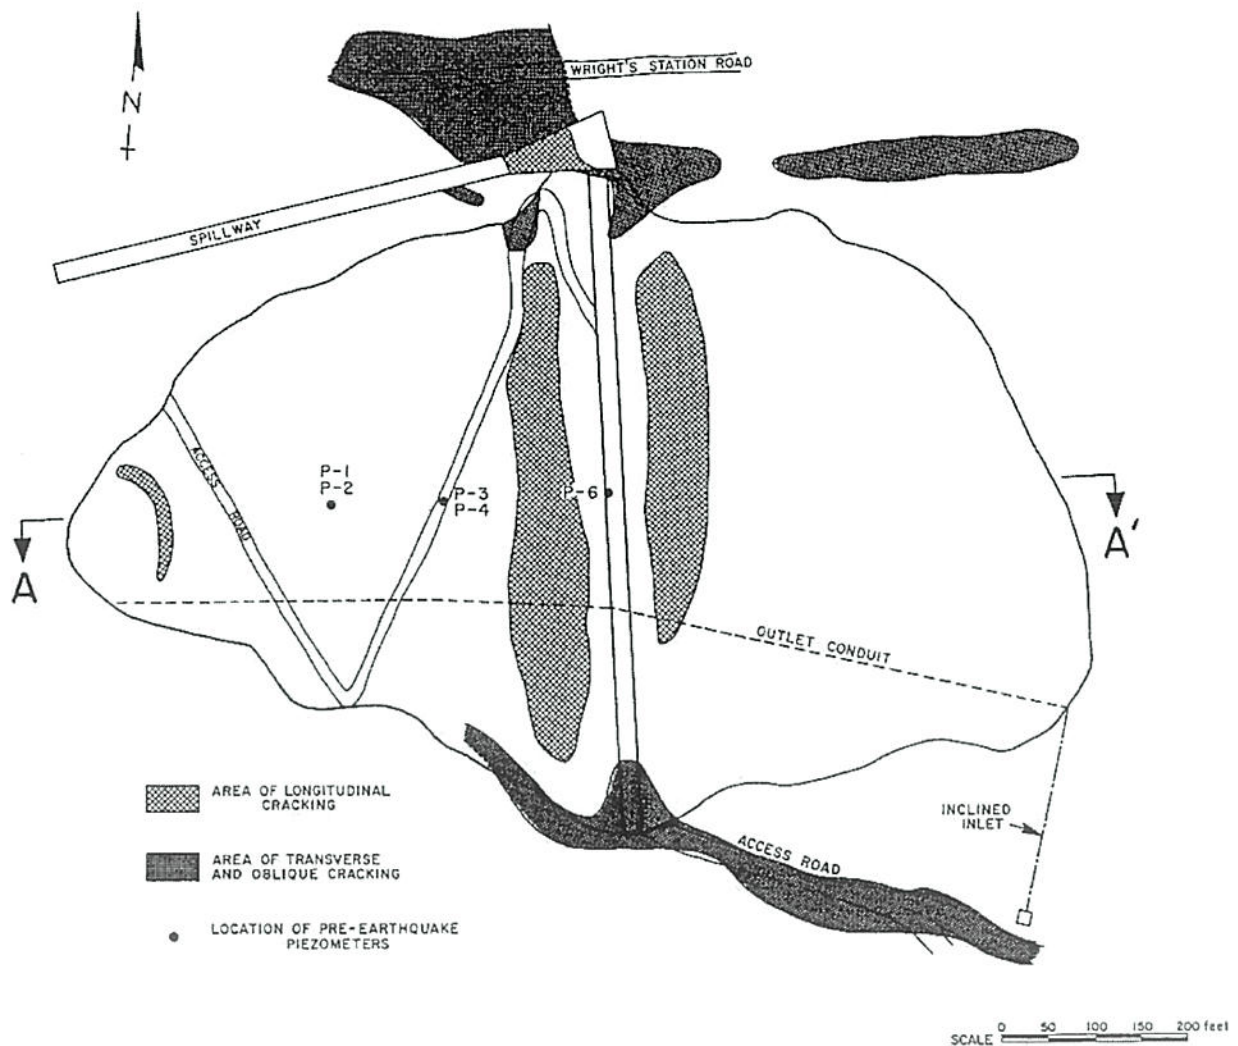
Figure 6  
Plan of Austrian Dam Showing Cracking  
(Forster and MacDonald, 1998)

Harder et al (1991) describe a series of **longitudinal cracks** on the upstream and downstream faces on the embankment, with lengths up to 120 metres (labelled "1" on figure 6). They state that initially these

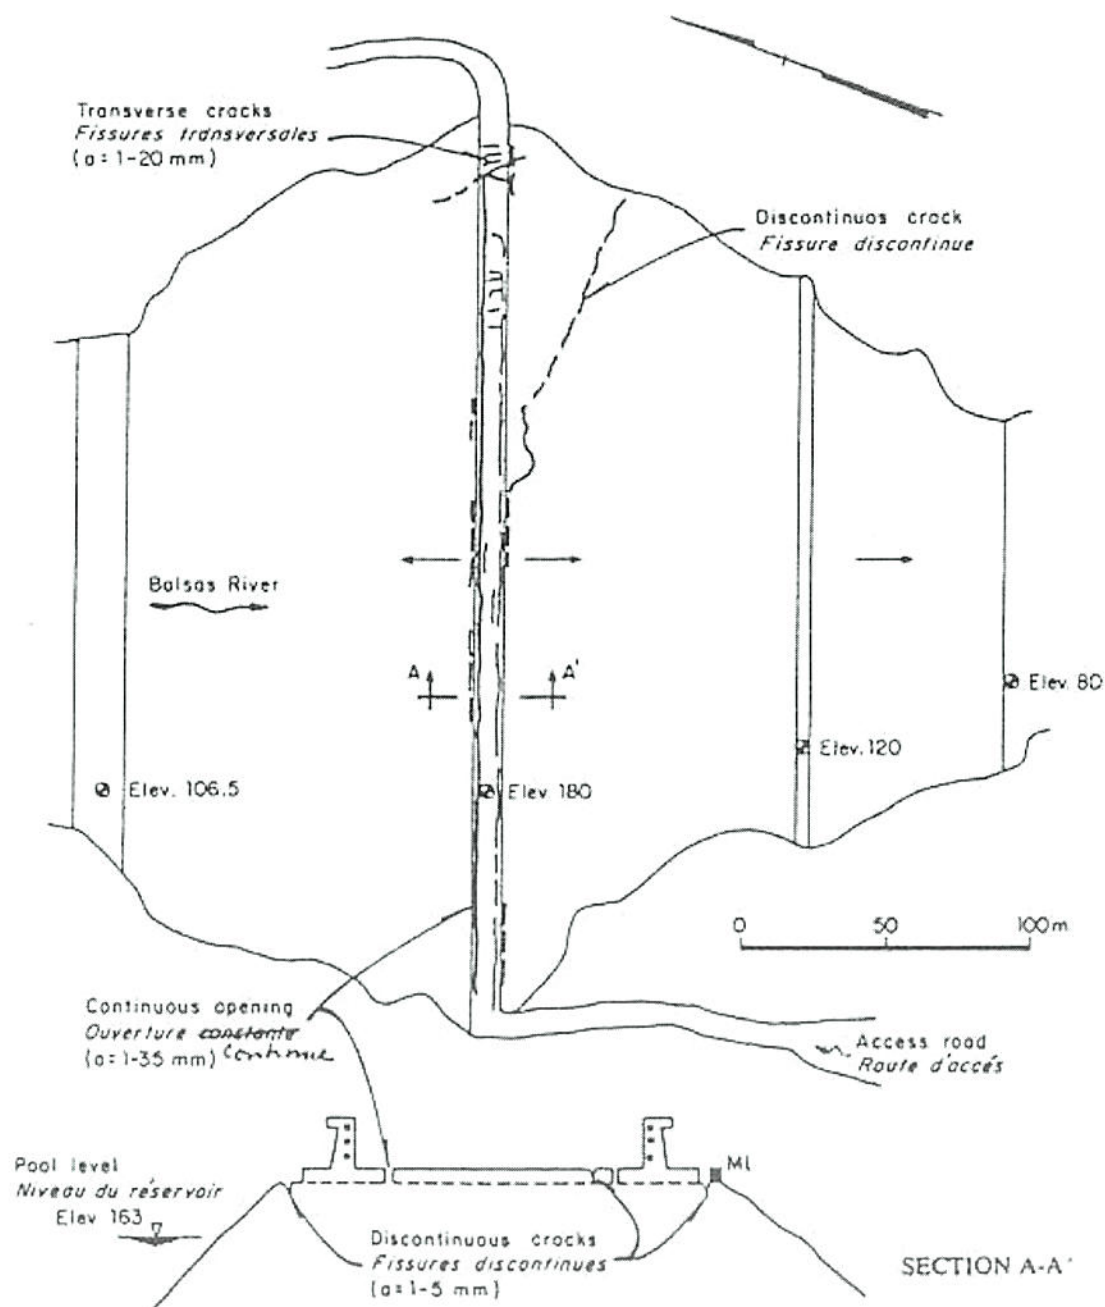
Figure 6 – Cracking Pattern of El Infiernillo Dam After the March 14, 1979 Earthquake

Most authors describe the damage to El Infiernillo Dam from the Guerrero earthquake to be 'minor', and included minor settlement, longitudinal and transverse cracking. Locations of cracking are shown on figure 6 below.

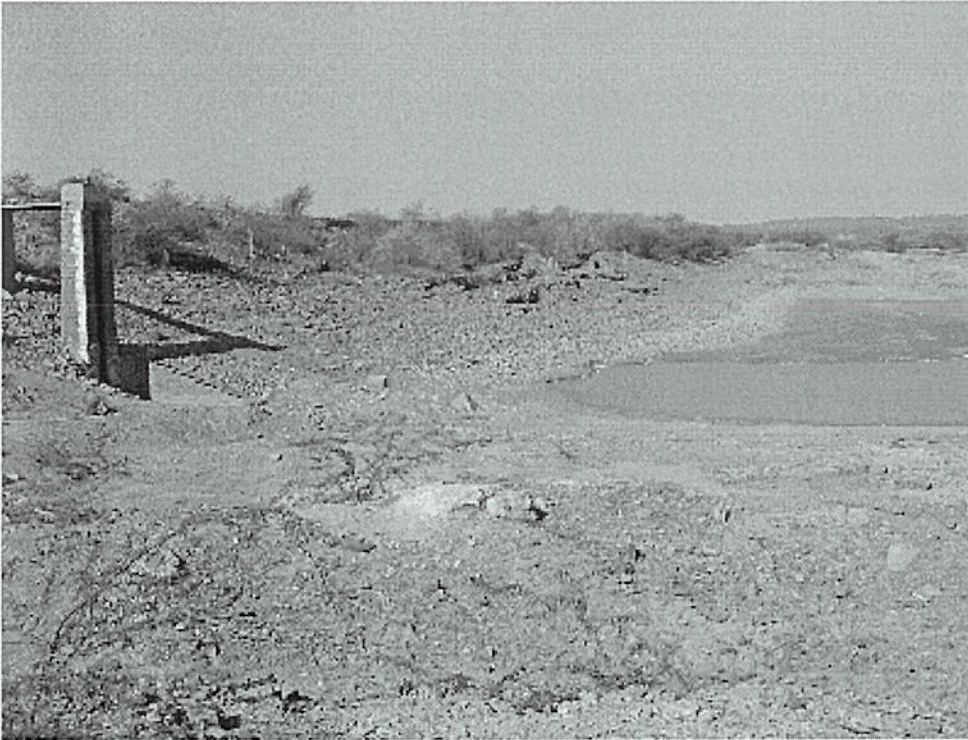
Shivlakha Dam experienced a failure that cut through the core. Cracking and slumping were observed on the up and downstream faces. Extensive failure of the upstream face occurred with cracks on the order of 3m vertical and horizontal. The abutment rock is composed of sandstone and mudstone.

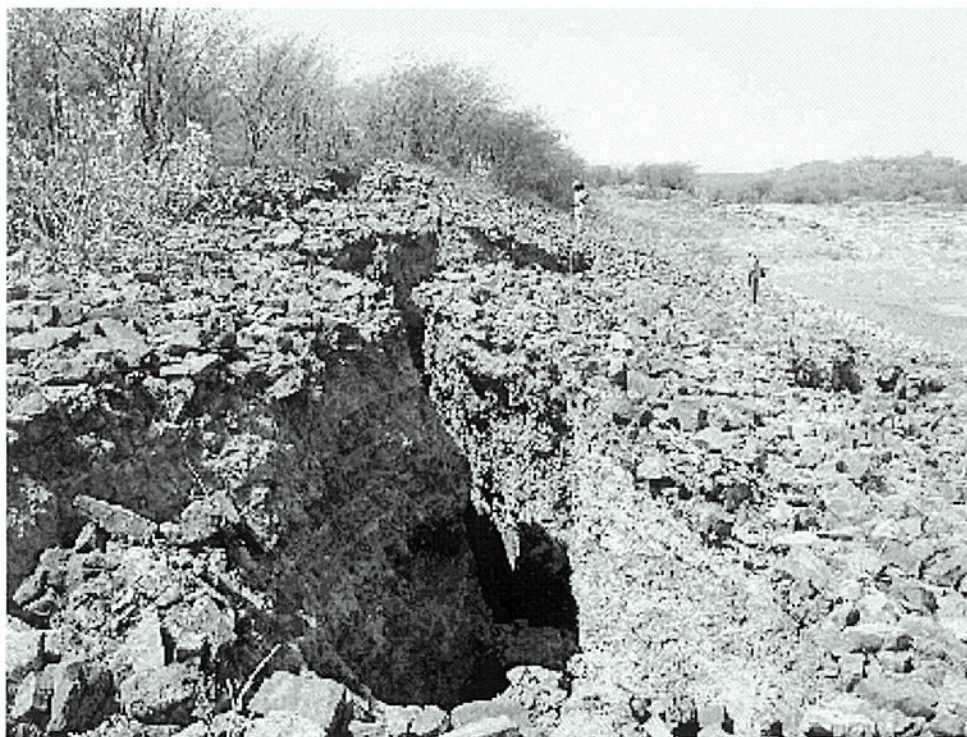
Large cracks on the upstream face.

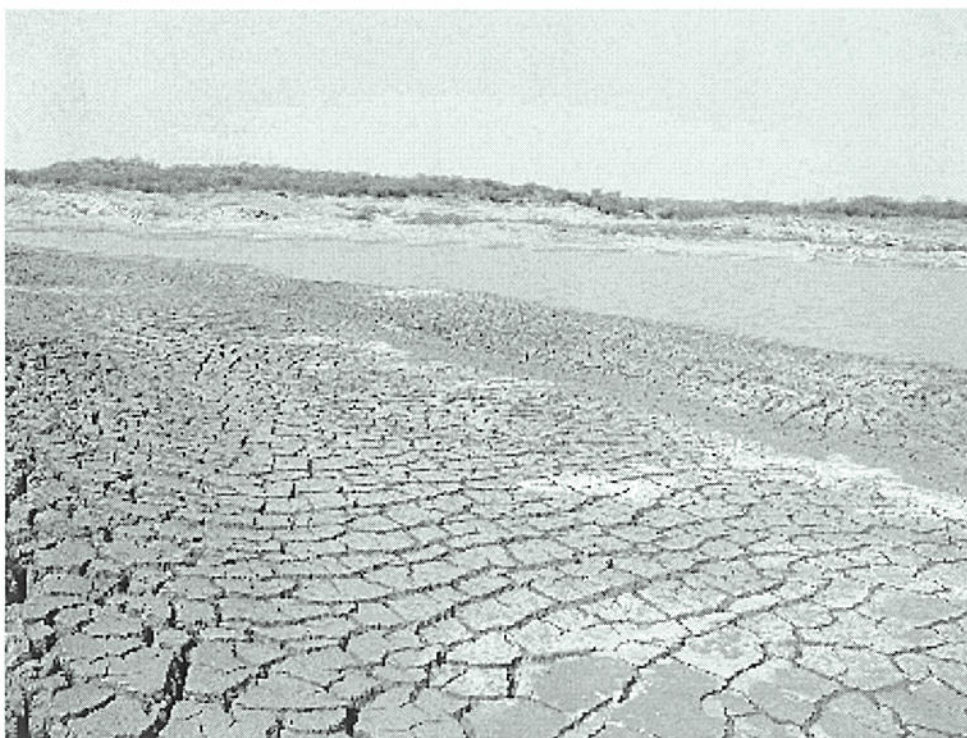
A bulge occurred at the upstream toe. A local farmer just upstream of the dam reported that water issued from ground fissures for approximately 0.5 hours on the day of the earthquake.

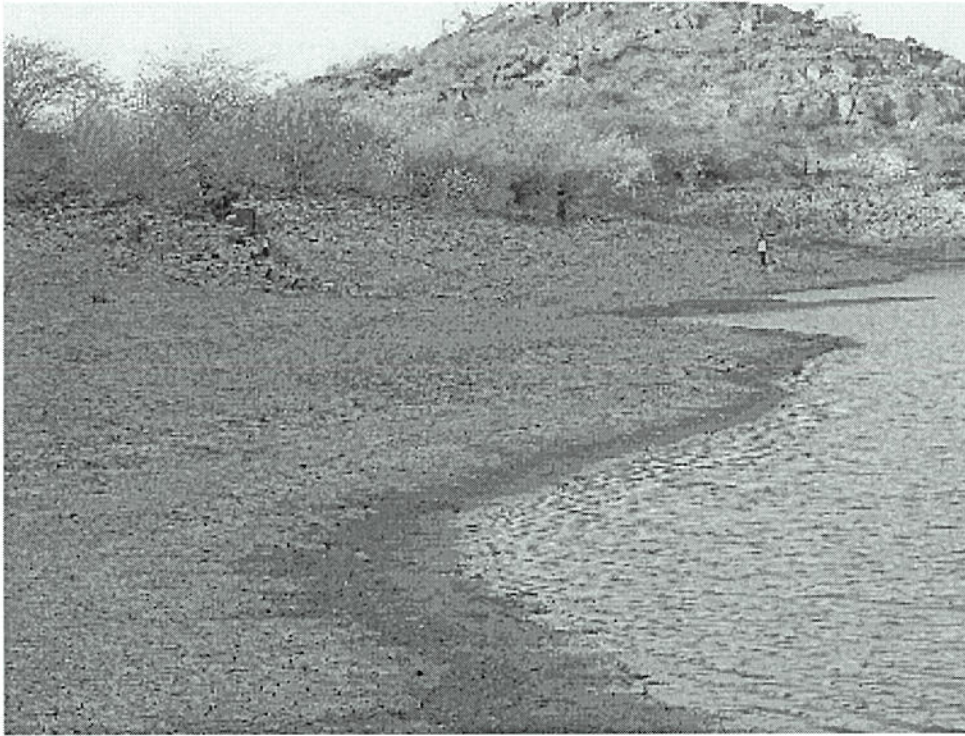
This dam experienced catastrophic failure of both the upstream and down stream faces with an overall crest drop of up to 10m. Chang Dam is located approximately 2km from observed tectonic ground deformations.

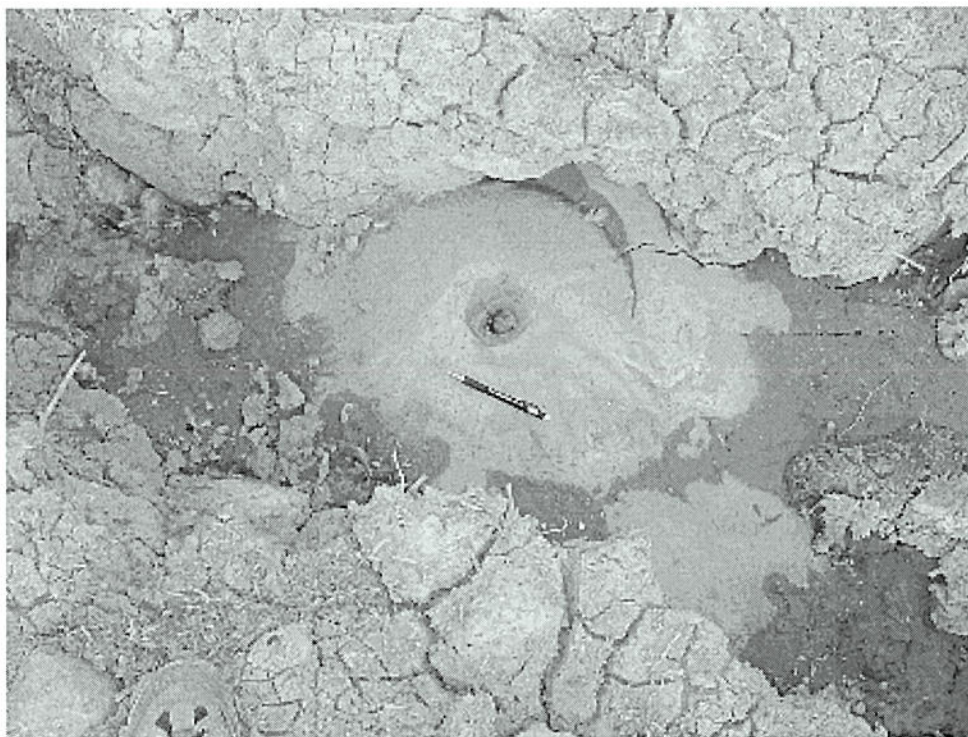
Numerous sand boils and fissures were observed along the toe region of the dam. Wide spread liquefaction occurred in and near the dam, and also along a large portion of the edge of the reservoir where lateral spreading on the order of 5m occurred. The ejecta was a silty sand with a clay crust on the surface. Huge quantities of ejecta covered a region of 200m<sup>2</sup> at the toe of the dam.

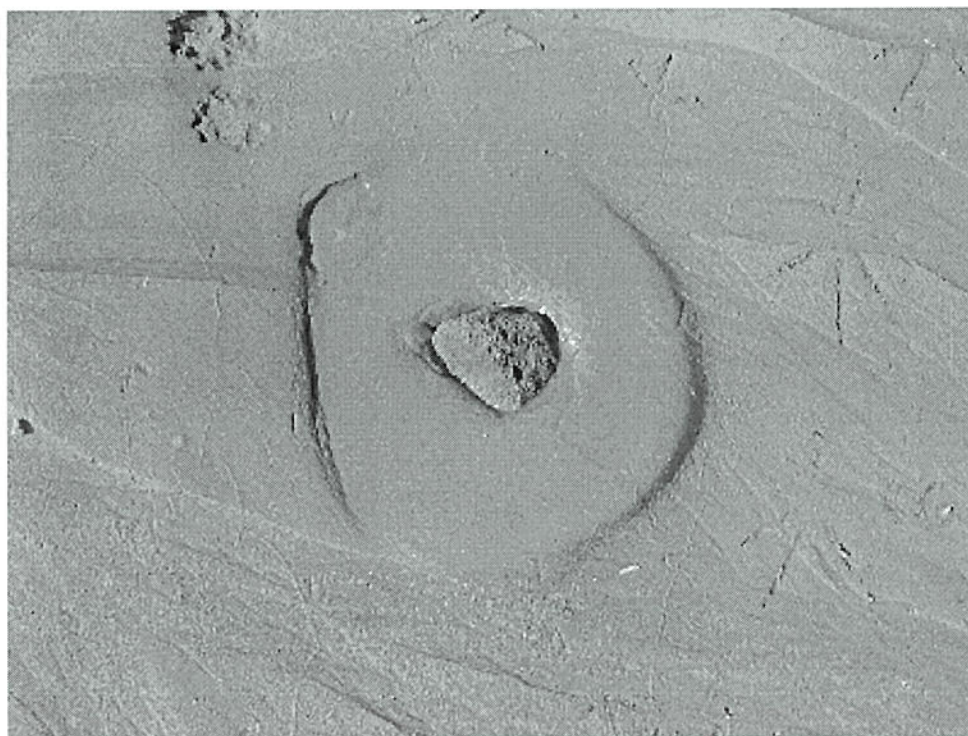
The silty sand ejecta remained saturated even after being exposed to direct sun light and high temperatures for up to 20 days after the main shock. Here the ejecta is shown to liquefy quite easily due to an impact load from a rock lobbed into the air.

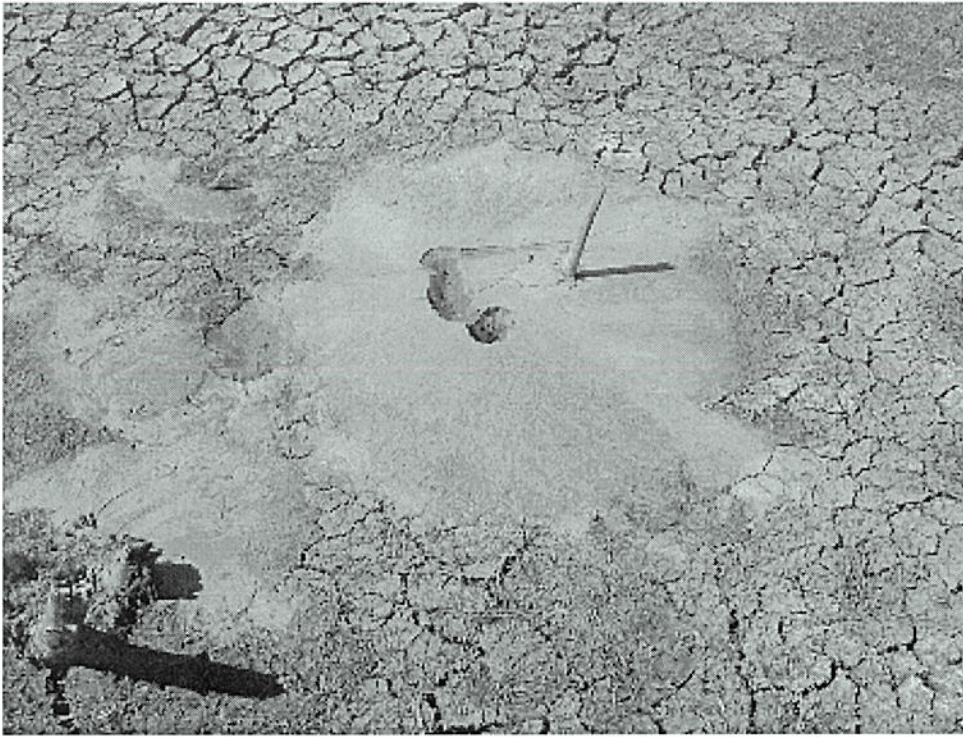
Sand boils and ground cracking due to lateral spreading were found along the upstream toe of the dam at both locations where large deformations of the dam occurred.

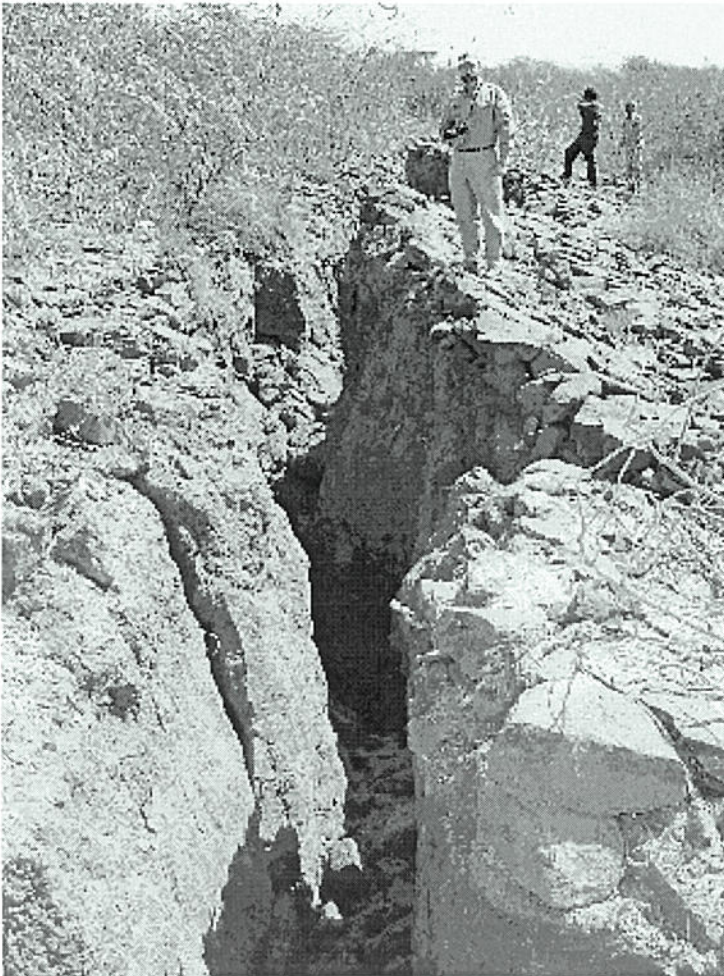
Cracks up to 6m deep were found on the upstream face with both translation and rotation evident.

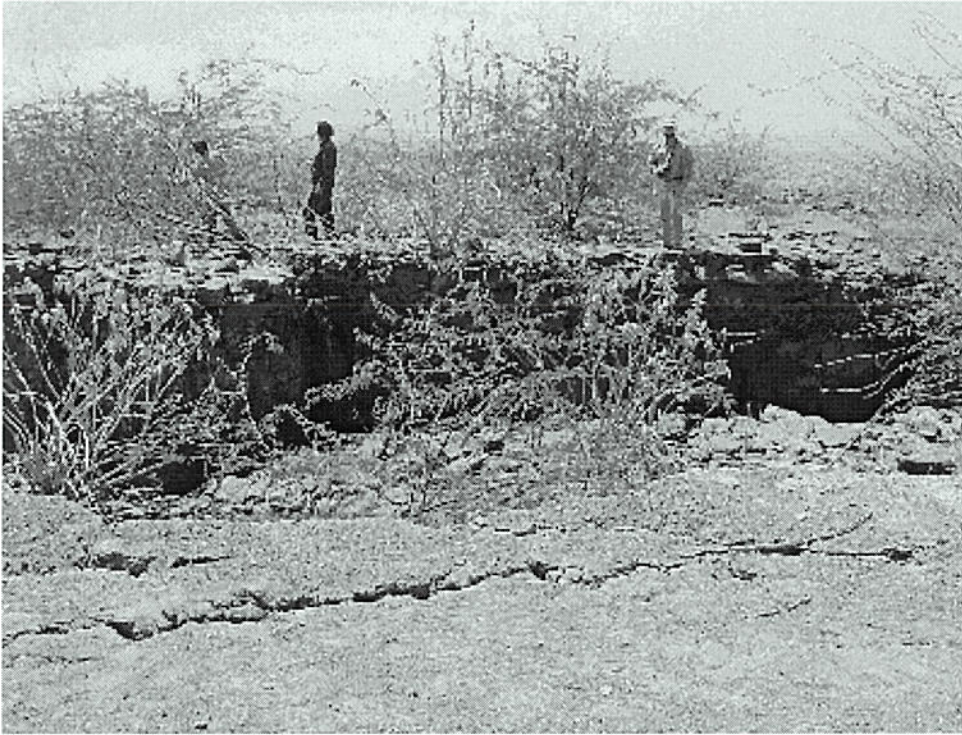
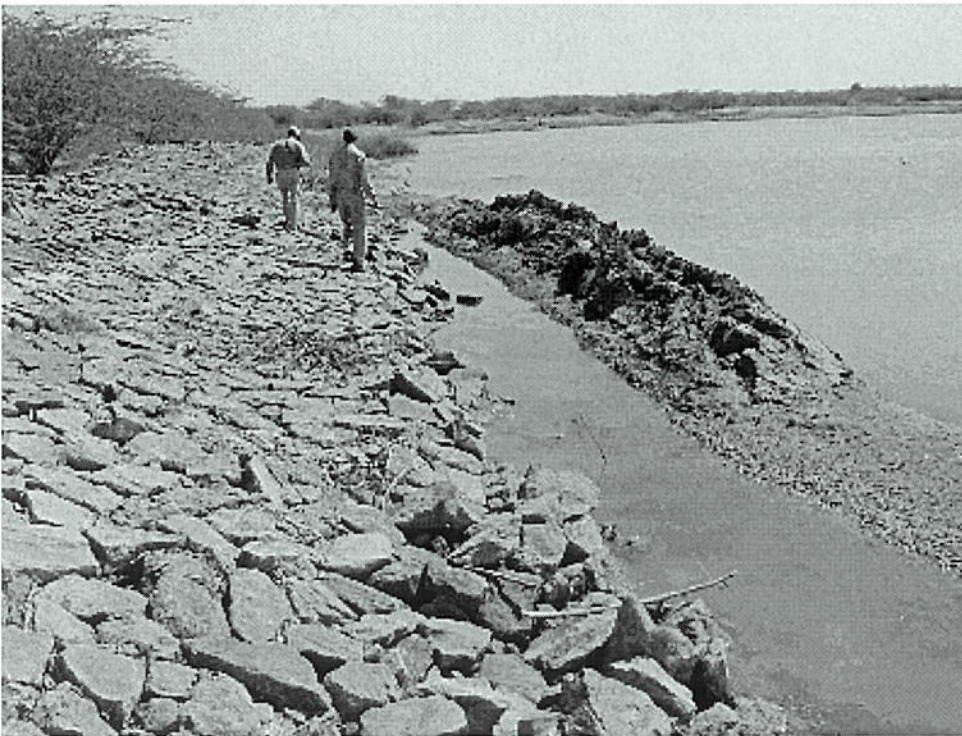
Large toe bulges consisting of silt and clay along the upstream toe.

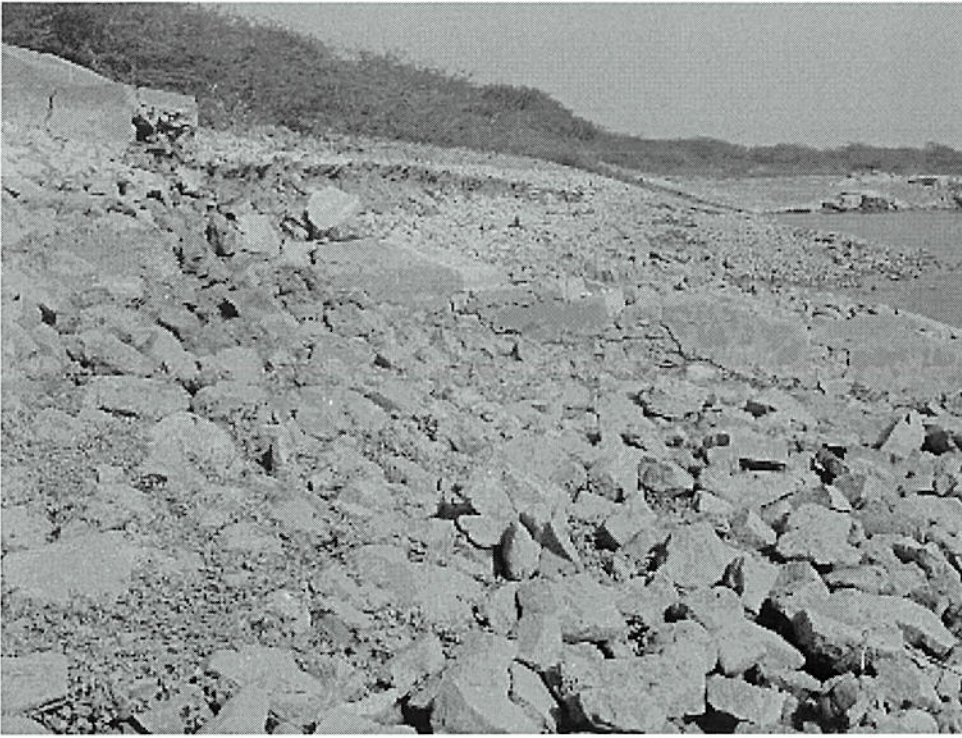
Cracking and slumping were observed along the upstream face. Scarps were up to 1.5m high with some evident rotation. Longitudinal cracks along the crest of the dam as well as toe bulges were observed.

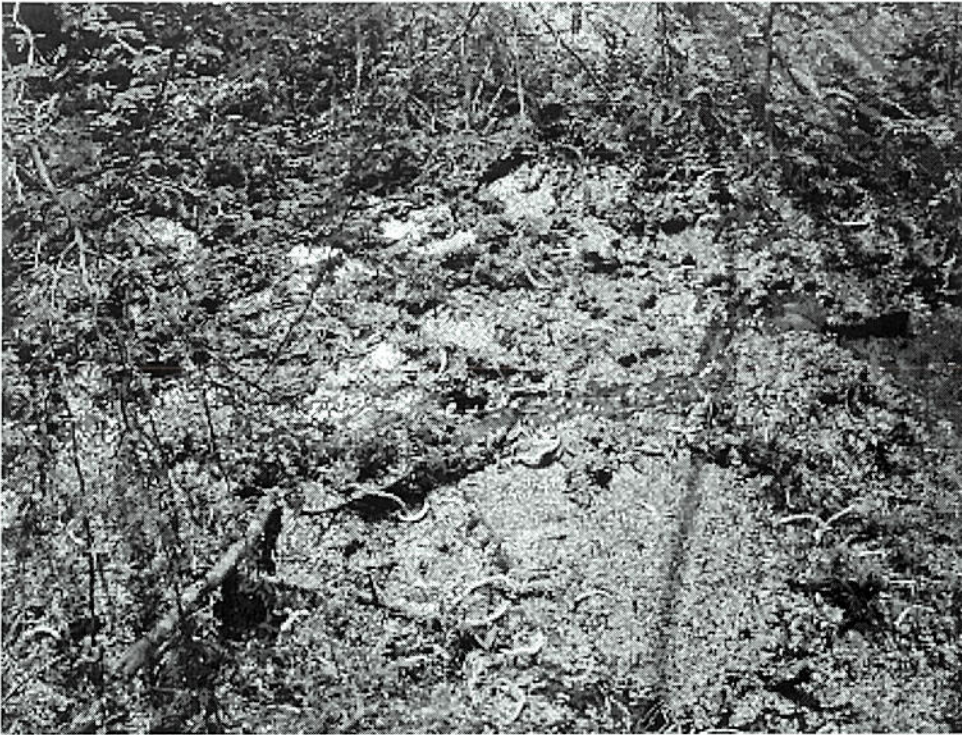
Uncontrolled seepage at the downstream toe began 2 days after the main shock. The seepage location corresponds to the damage on the upstream face.

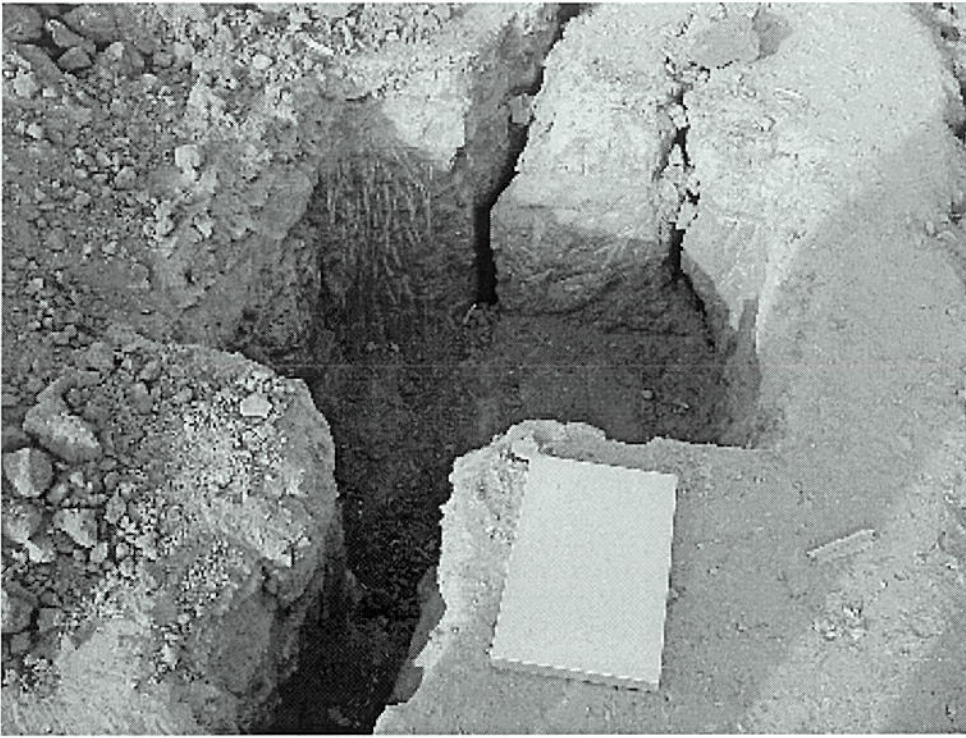
Longitudinal crest cracks up to 75mm wide and 1m deep stretch over a significant length of the dam.

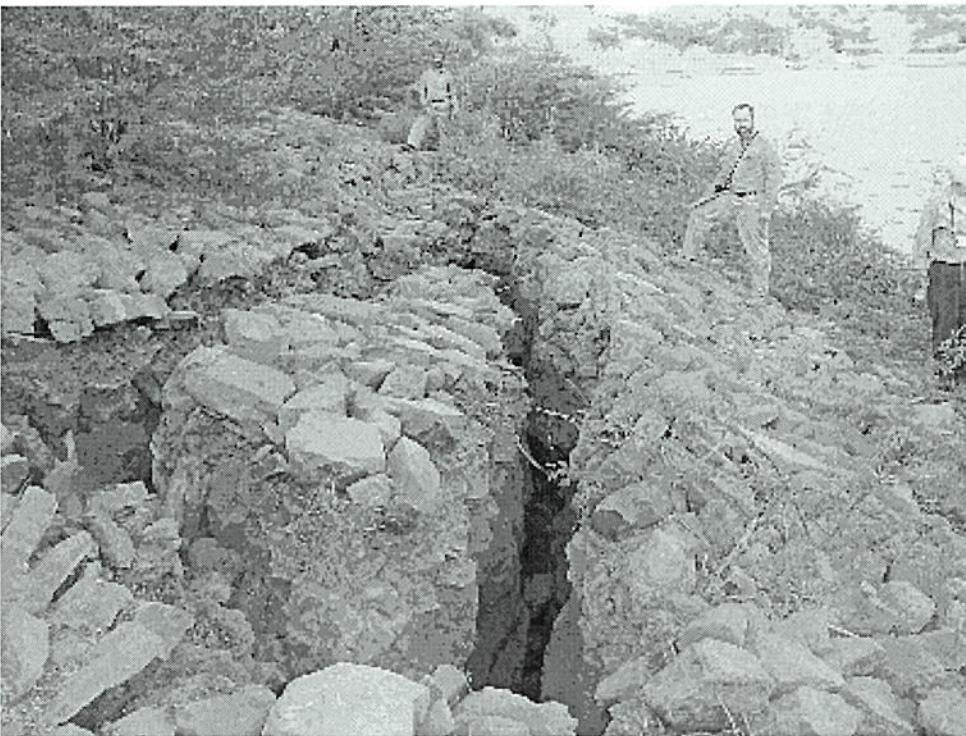
Cracking was observed on the upstream face of the dam up to 2m deep and 0.75m across.

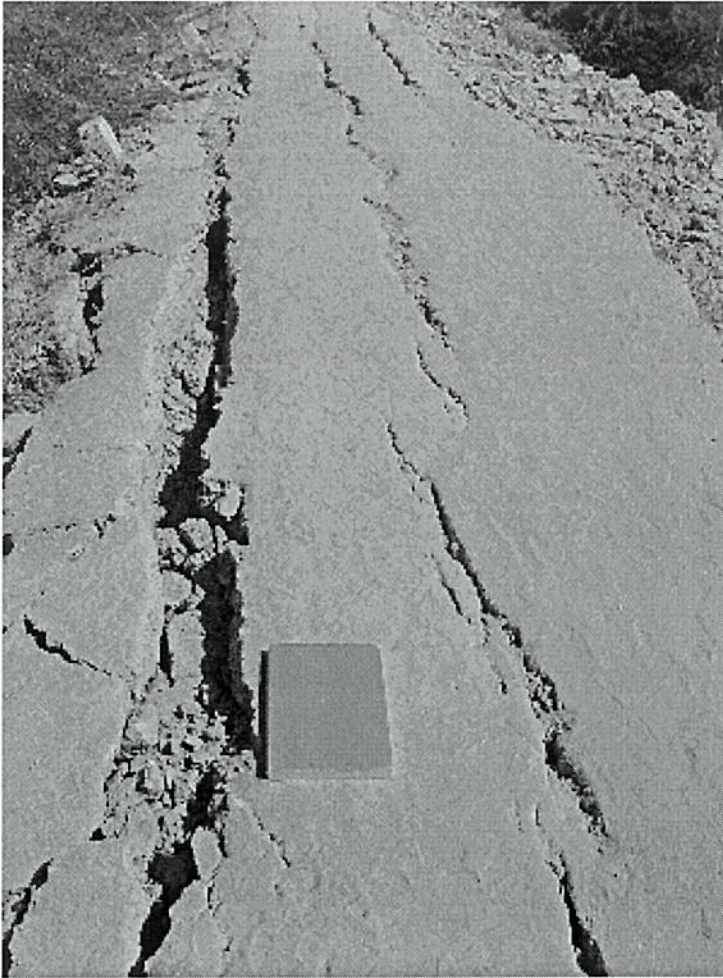
Significant longitudinal crest cracking with a 1m drop in crest height at the deepest section. Collapse of a sluice gate and associated stairway occurred. Cracking and deformation was observed on the upstream face with scarps on the order of 0.75m high.

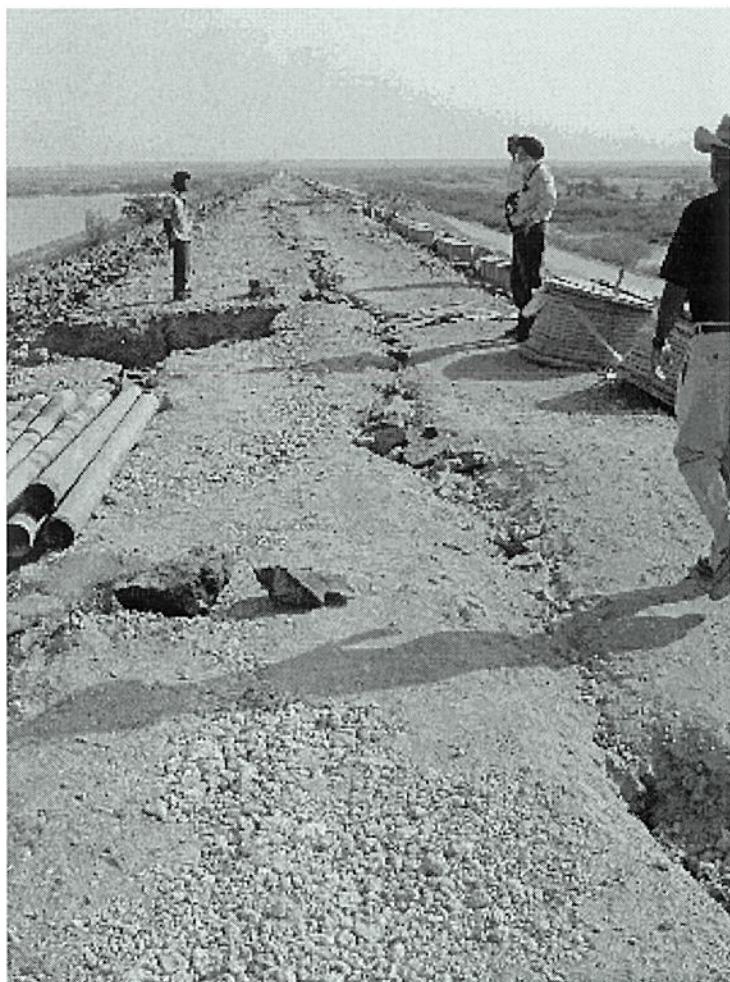
Tapar dam is the most important dam to the region, supplying drinking and agricultural water to the surrounding urban and rural cities and towns. Longitudinal crest cracking up to 1m wide and 300m long was observed.

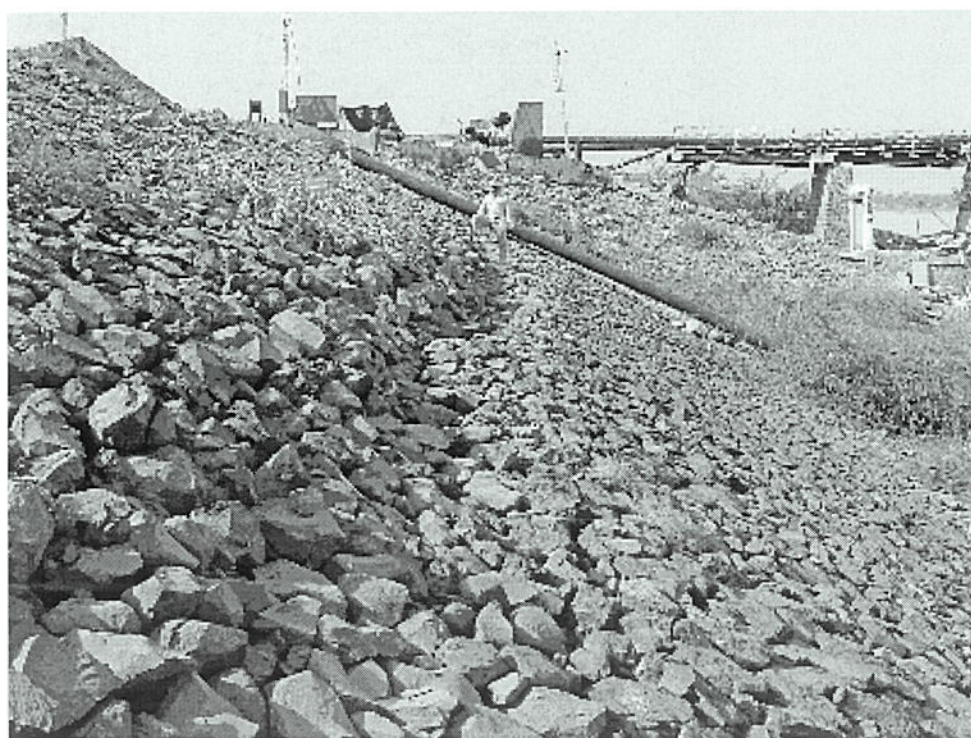
Failures on the upstream face with scarps on the order of 0.75m high.

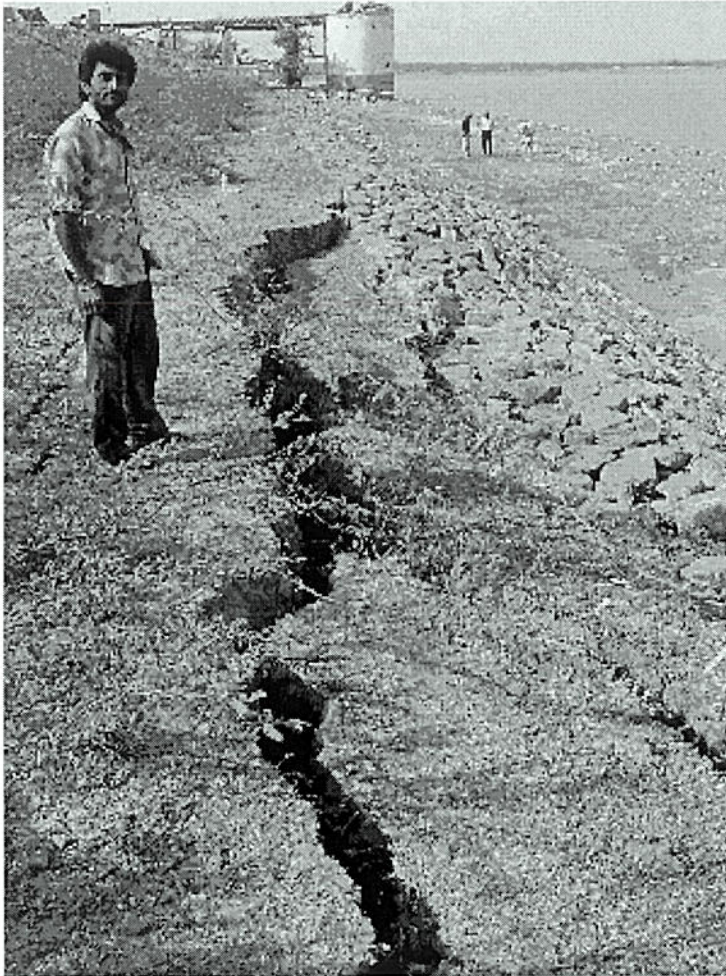
Lateral spreading at the toe and along the lower upstream face.

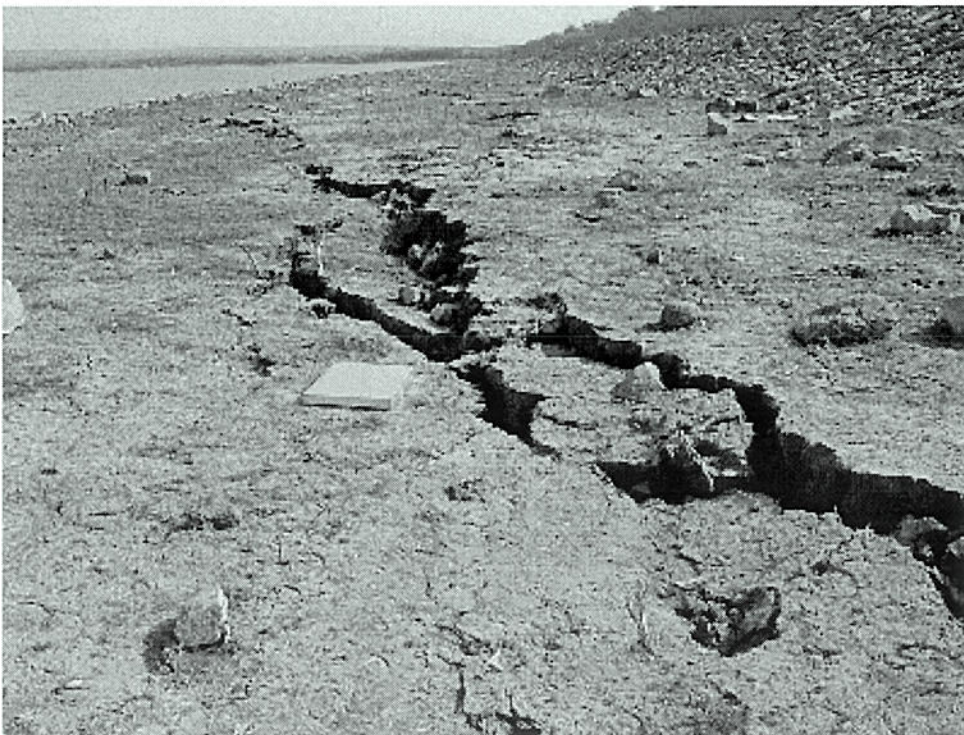
Cracking here associated with liquefaction along the upstream toe.
