**DAMAGE AND CRACKING OF  
EMBANKMENT DAMS BY EARTHQUAKES  
AND THE IMPLICATIONS FOR  
INTERNAL EROSION AND PIPING**

STEVEN PELLIS AND ROBIN FELL

UNICIV REPORT No. R-408 JANUARY 2002  
THE UNIVERSITY OF NEW SOUTH WALES  
SYDNEY 2052 AUSTRALIA  
<http://www.civeng.unsw.edu.au>

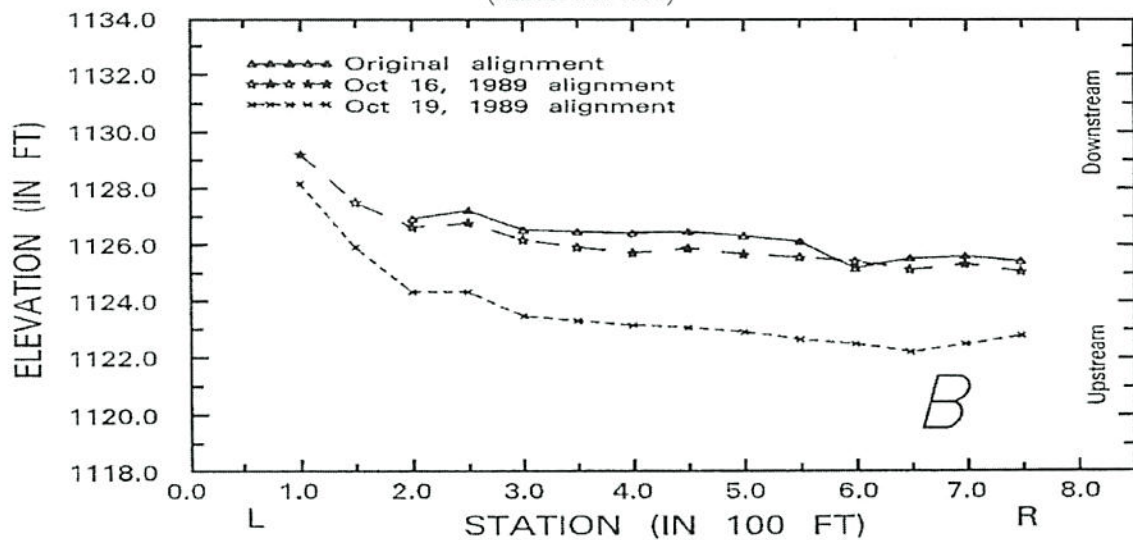
**Figure 3**  
**Vertical Movements of Crest Monuments**

The Austrian Dam suffered the most damage out of all dams affected by the Loma Prieta earthquake. Damage included settlements (figure 3), deformations in the form of upstream / downstream movement (figure 4) and longitudinal and transverse cracking (figures 5 and 6). The concrete spillway was also severely damaged.

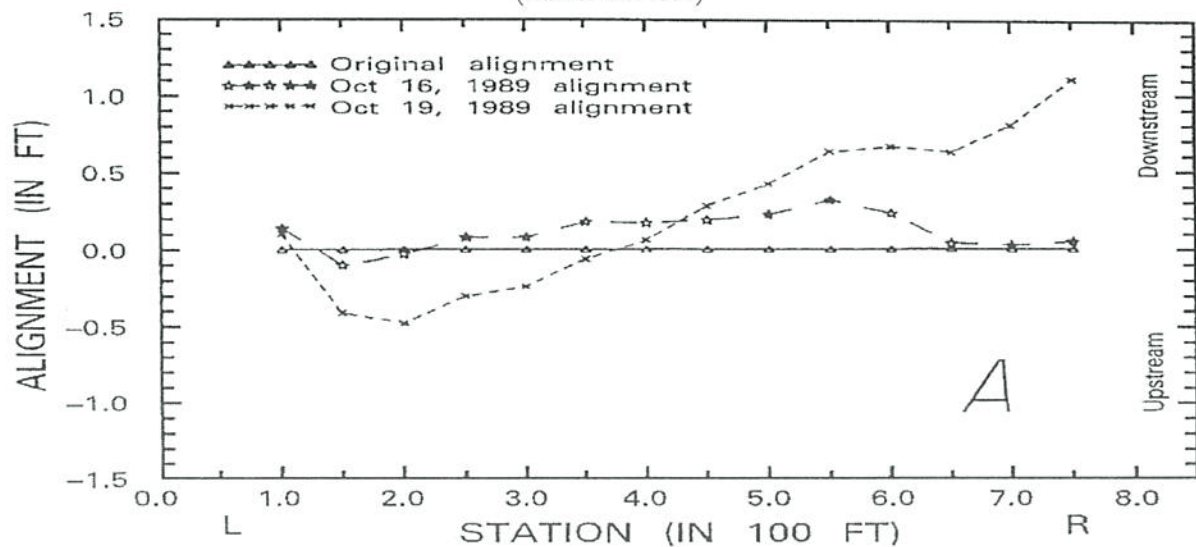
**Figure 4**  
**Horizontal Movements of Crest Monuments**

The embankment was **deformed laterally** under the quake loadings with the right end of the embankment

moving 370mm (1.2 ft) downstream, and the left moving 150mm (0.5 ft) upstream (See Figure 4). However, apparently the monuments were not tied to a stationary benchmark and so absolute displacement vectors could not be determined. Analysis of the dam suggests that horizontal movement was 'generally downstream'.

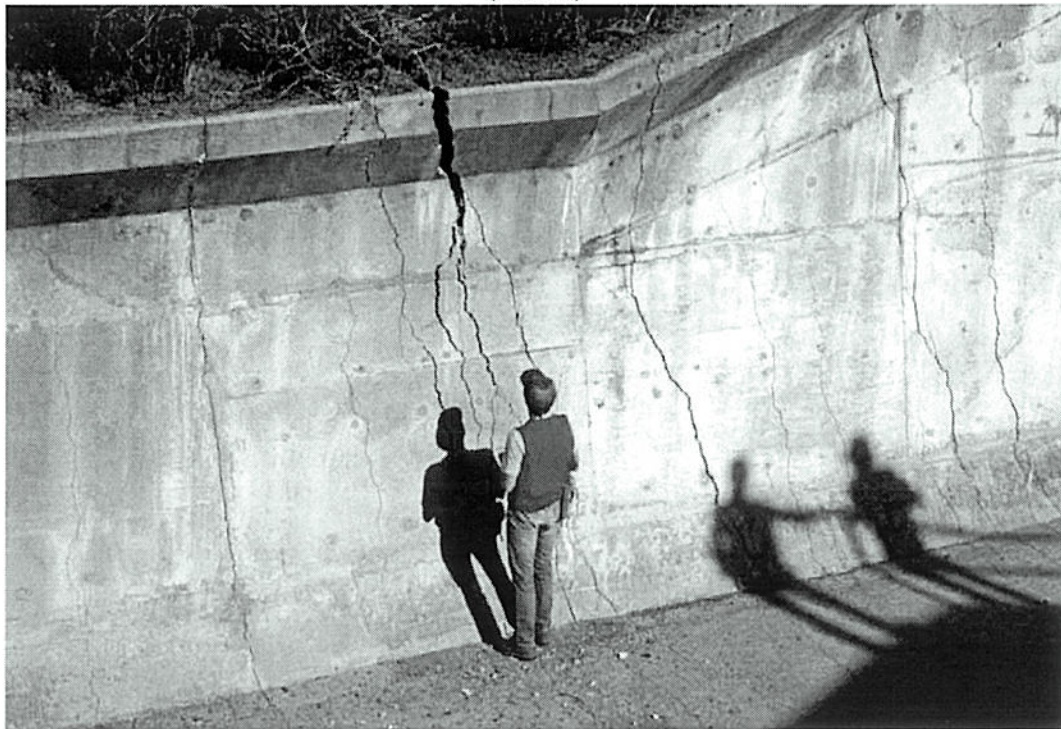
**Photo 2**  
**Cracking of Spillway Walls at Austrian Dam**  
(U.S.G.S)

The spillway suffered severe damages (labelled “5” on figure 6). Tensions cracks formed perpendicular to the spillway axis through out the length of the spillway, such that it was elongated by over 300 mm (Forster and MacDonald, 1998; and Harder, 1991). Photo (2) shows as cracked section of the spillway – with cracks up to 120 mm wide (U.S. Geological Survey). According to Forster and MacDonald (1998) it was damage to and around the spillway, which gave evidence that the spillway experienced side to side rocking under the earthquake loading. Explorations found areas under the left wall where rocking had produced separations of up to 25 mm between the base of the spillway and the embankment material – also of great concern had the reservoir been full. The movement of the spillway also resulted in several cutoff collars being sheared off.

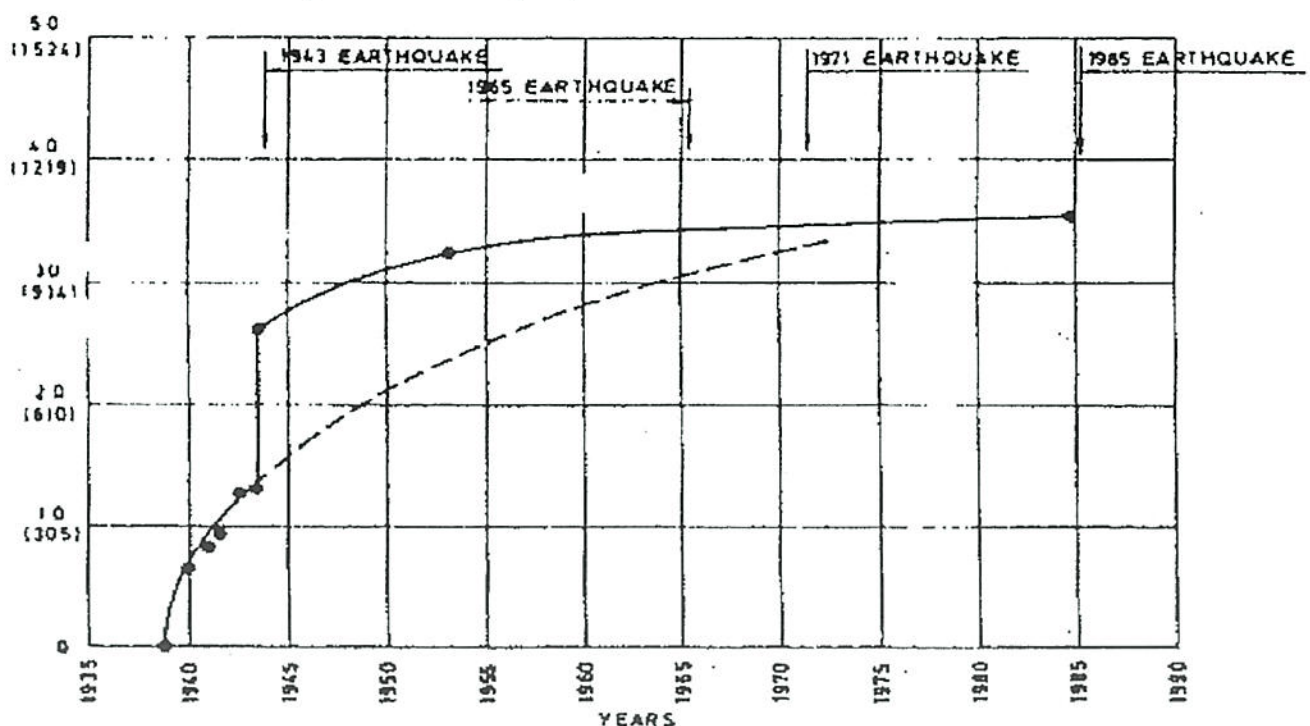
The principal effect of the Illapel quake on Cogoti dam was **settlement**. As a consequence of the quake, the dam was reported to experience immediate settlements on the crest of 410mm. This is about 0.48% of the dam maximum section height. However, the point of maximum settlement was measured near the centre of the crest, which, interestingly, is not the point of maximum dam height. At the centre, the dam height is about 63 metres, whereas near the right abutment, the maximum section is about 85 metres. It is said that the settlement was less at the maximum height 'because of a restraining effect due to the nearby presence of the very steep abutment' (ibid). The measured earthquake induced settlement of 410mm is said to be equivalent to that of 'natural' settlement observed over a period of 4.5 years after completion of the dam. Figure 3 shows settlements of the dam since construction – although the units are unclear, the significance of settlements as a consequence of the Illapel quake is evident.

The dam continued to settle after the quake, but at a rate slightly less than what was predicted had the quake not occurred (see Figure 3). The Illapel quake showed a much greater response in settlement compared to other earthquake events – which, according to ICOLD, can be attributed to the closer proximity of the Illapel quake (other quakes were over 165 km away). Other quakes are estimated to have produced peak ground accelerations at the Cogoti site of not greater than 0.05g.

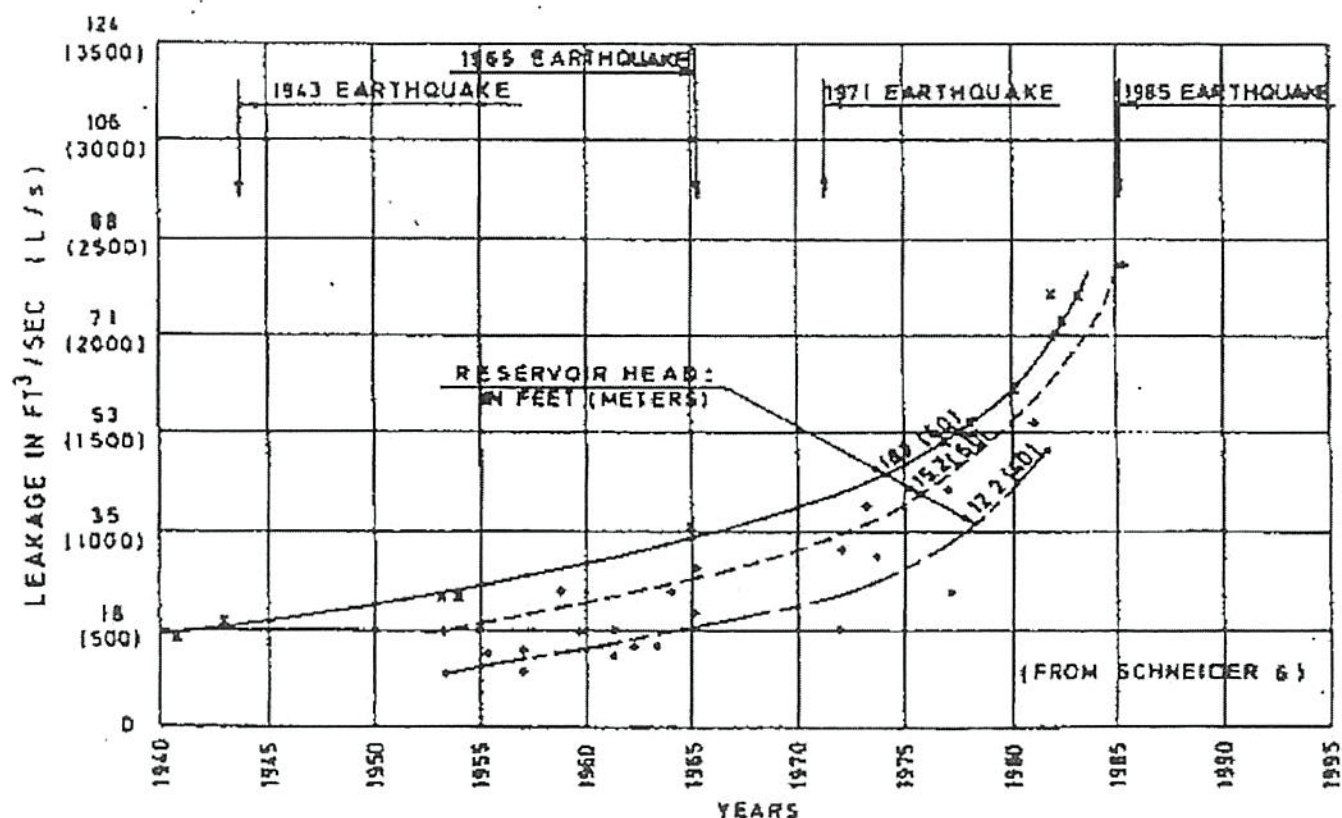
Figure 4 Leakage at Cogoti Dam

Figure 4 shows seepage at Cogoti dam since construction. **Leakage** has been observed since construction, but as shown, is related only to reservoir height, and is attributed in ICOLD (1999) mainly to flow through the foundation. The increase over the years has been attributed to aging (ICOLD, 1999), and not to any earthquake events. Arrau et al (1985) believe the majority of seepage is through joints in the slab and through perimeter joints.

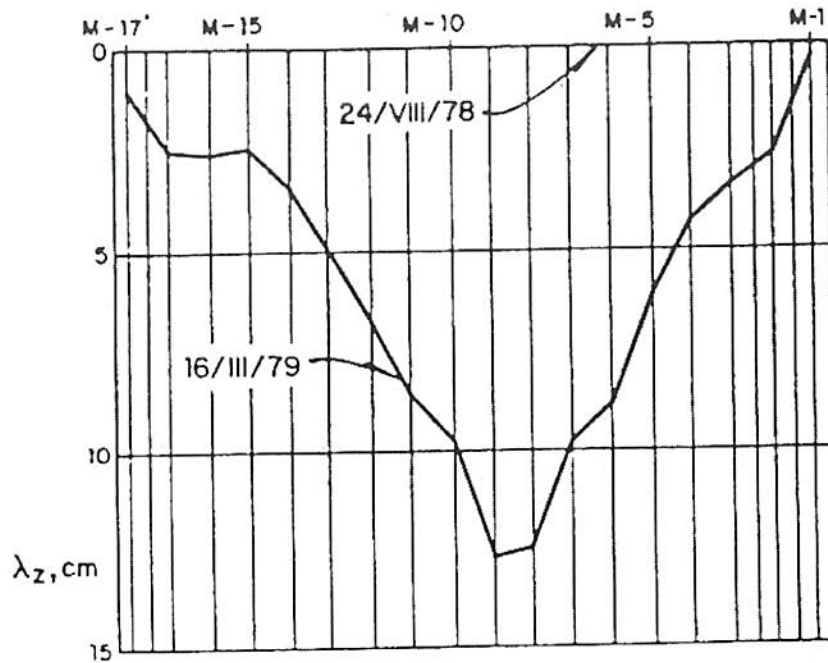
Figure 7

**Longitudinal cracking** included one significant continuous crack 1 to 35 mm in width just upstream of crest and various discontinuous cracks 1 to 5 mm width. Some **transverse cracking** of 1 to 20 mm width occurred adjacent to left abutment. **Settlements** of up to 120mm were recorded on the crest and are shown in figure 7 below

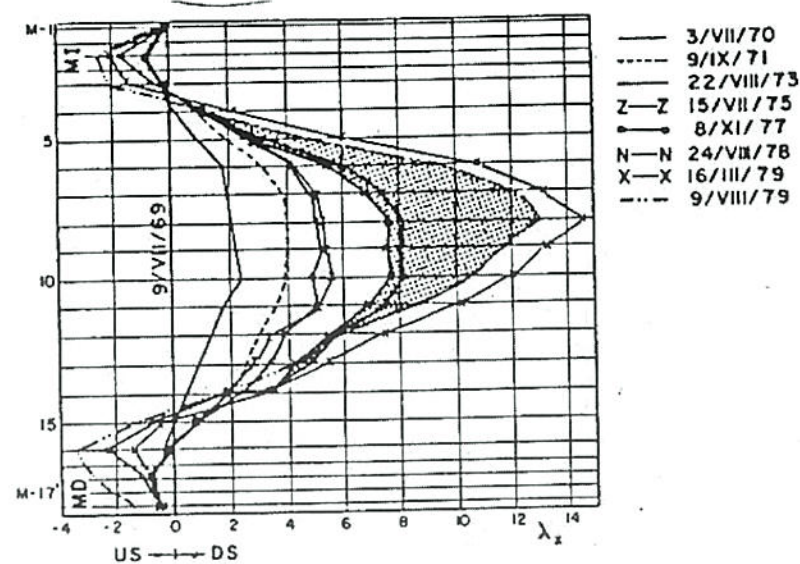
Figure 8 – Shaded Area Represents Effects of the Guerrero Earthquake

A history of settlements at El Infiernillo, including the Guerrero earthquake, is shown in Figure 8 below.

The effects of the Guerrero earthquake are significant on all the above plots. Resendiz et al (1982) point out that this is was the first time El Infiernillo suffered permanent seismic deformations, despite being struck by several earlier quakes. The maximum crest acceleration of prior events was 0.23g (compared to the Guerrero acceleration of 0.36g) and produced at most only a temporary minor increase in settlement rates.

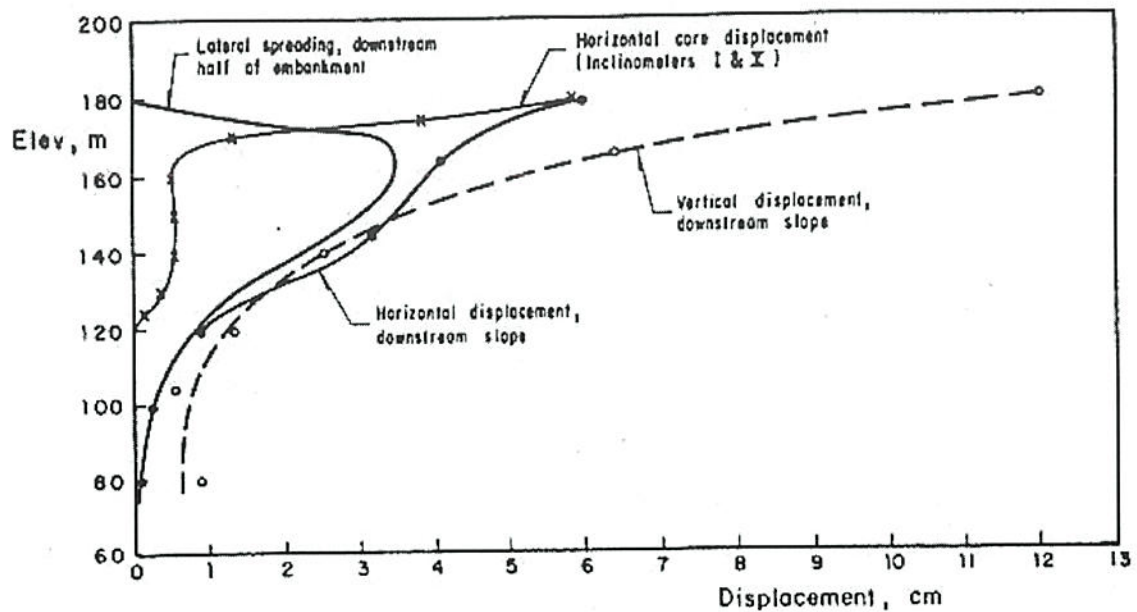
Because of the extensive monitoring installed at El Infiernillo, a plot of the displacements of the core and downstream slope is available as is Figure 9 below. Resendiz et al (1982) estimate that approximately 27% of the crest settlement in El Infiernillo dam is due to lateral spreading.

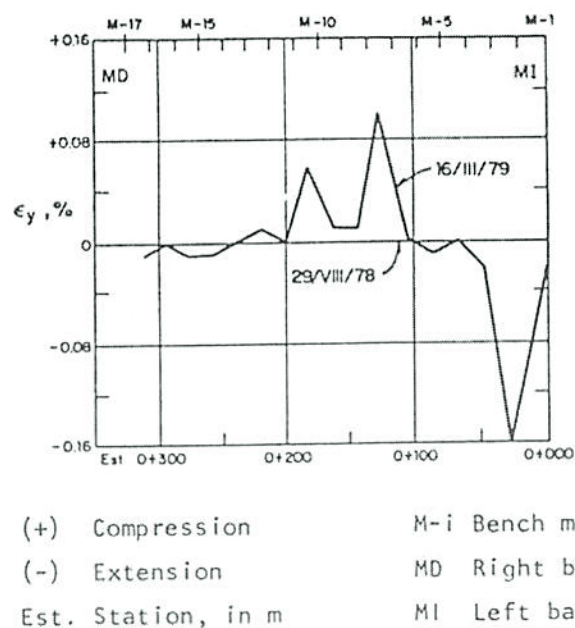
Figure 10 – Variations of Longitudinal Strains Along the Crest of El Infiernillo Dam

Length measurements between crest benchmarks provided the information to produce a plot of variations of longitudinal strain along the crest as shown in Figure 10

The extent of settlement and deformation data made available through the extensive instrumentation at El Infiernillo allows some examination of the mechanics of the cracking. Resendiz et al (1982) write of the data “the positive correlation between the intensity of longitudinal cracking and magnitude of settlements is beyond doubt”. They point out that five lines of longitudinal cracking (in the center of figure 6) correspond to the location of maximum settlement in figure 7, where only one to three lines occur in zones of less settlement. They also comment on the location of transverse cracking and its relationship to maximum tensile strains in figure 10.

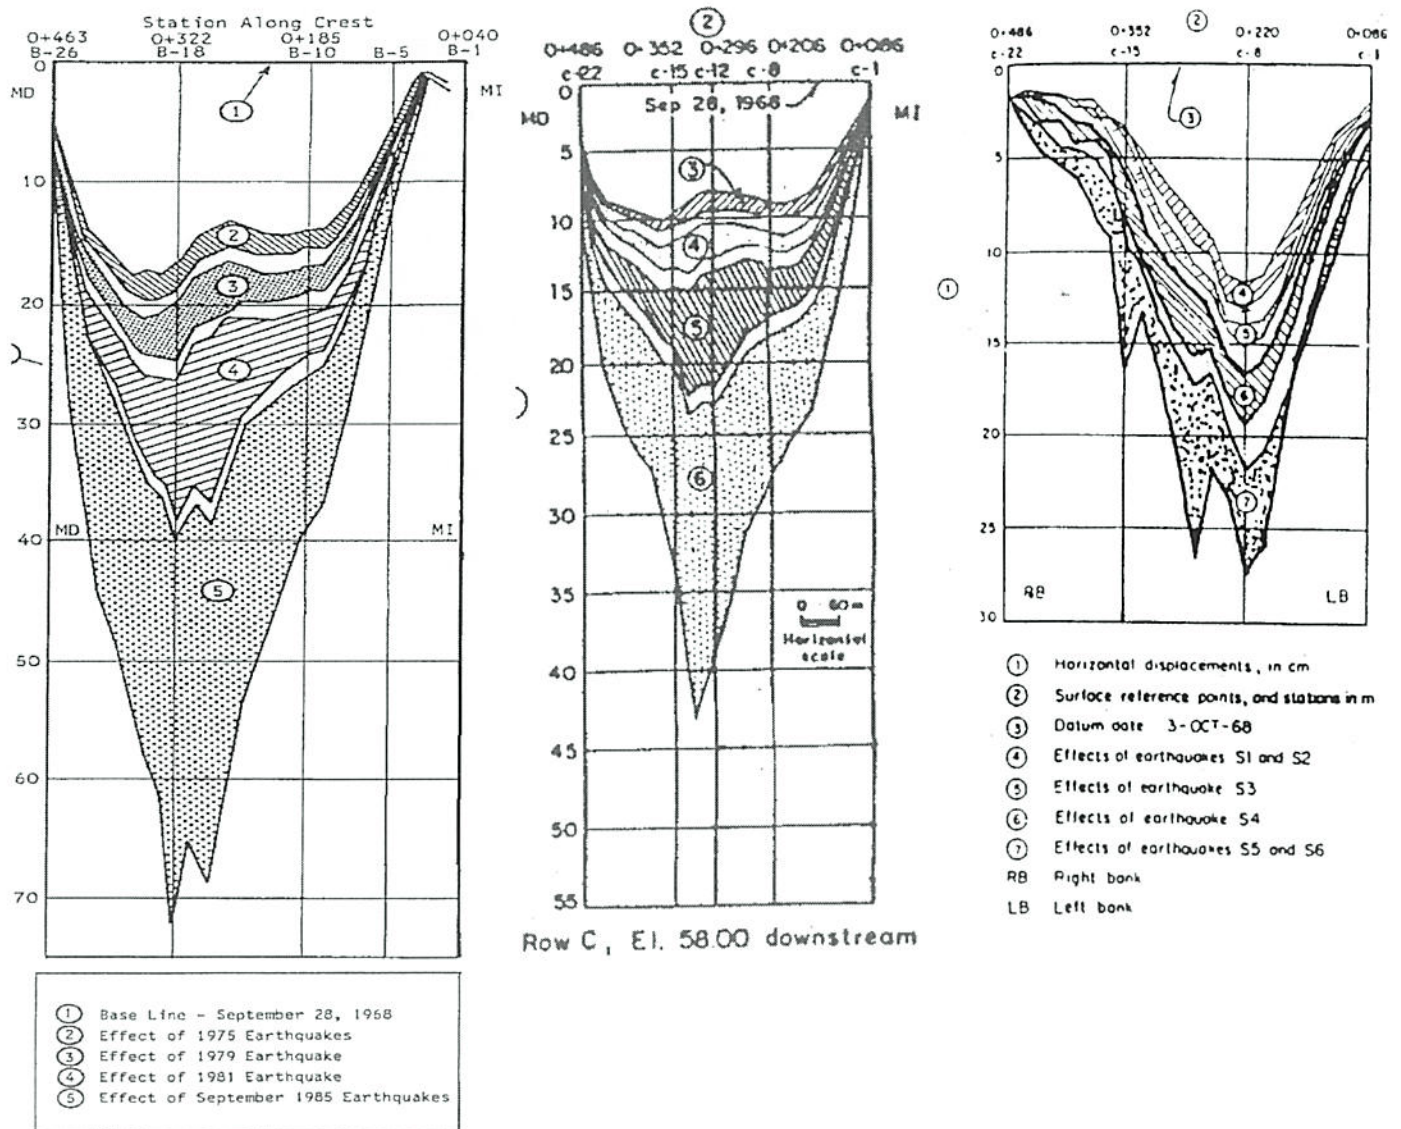
The extensive instrumentation installed at La Villita has allowed close monitoring of the embankment since construction and throughout the many earthquakes. Data on the settlement that has occurred from construction until the September 1985 is shown in figure 3 a, b and c. Elgamal et al (1990) report that in all earthquakes, there have been evident 'localised zones of low strength and differential settlements'. They attribute this to: the variable thickness of the alluvium; the inhomogeneous compressibility (see 'Embankment Details' above); and, the zoned cross section.

Figure 3 a b and c Showing Displacements in centimeters. A: Vertical Displacement Upstream; B: Vertical Displacements Downstream; C: Horizontal Displacements

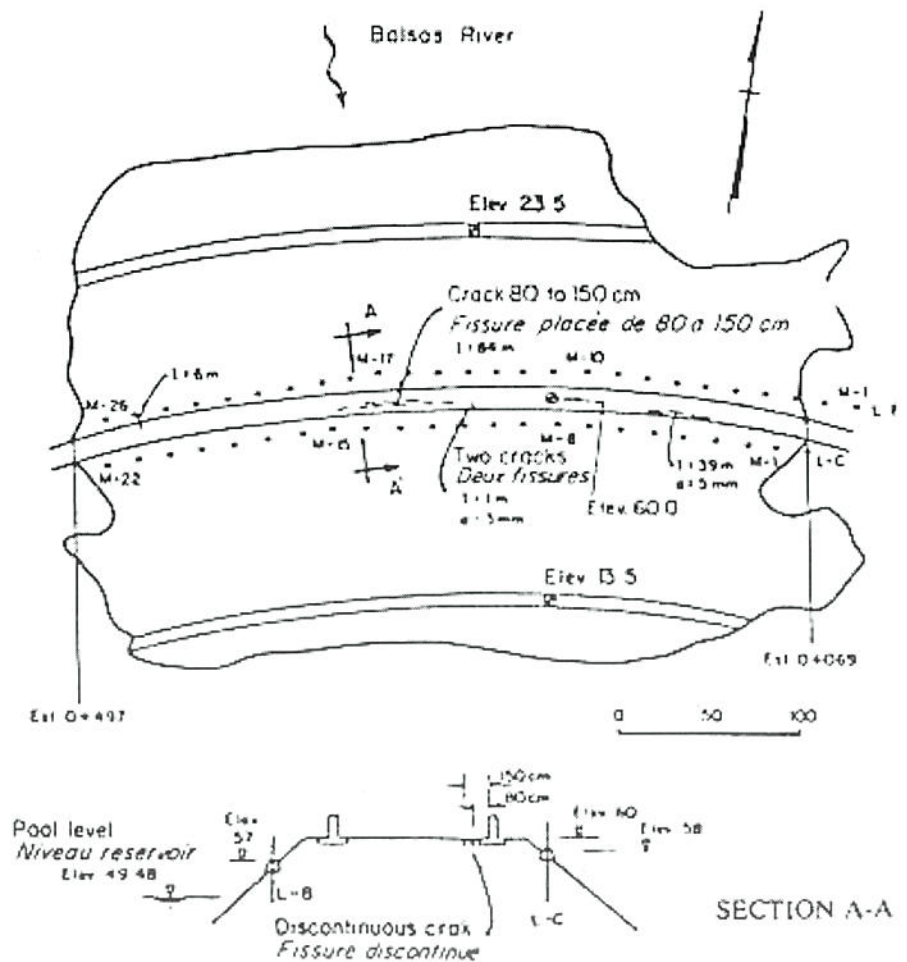
Figure 5

Resendiz *et al* posit that the distribution of longitudinal cracks align well with the distribution of settlements (see figure jdjjdj).

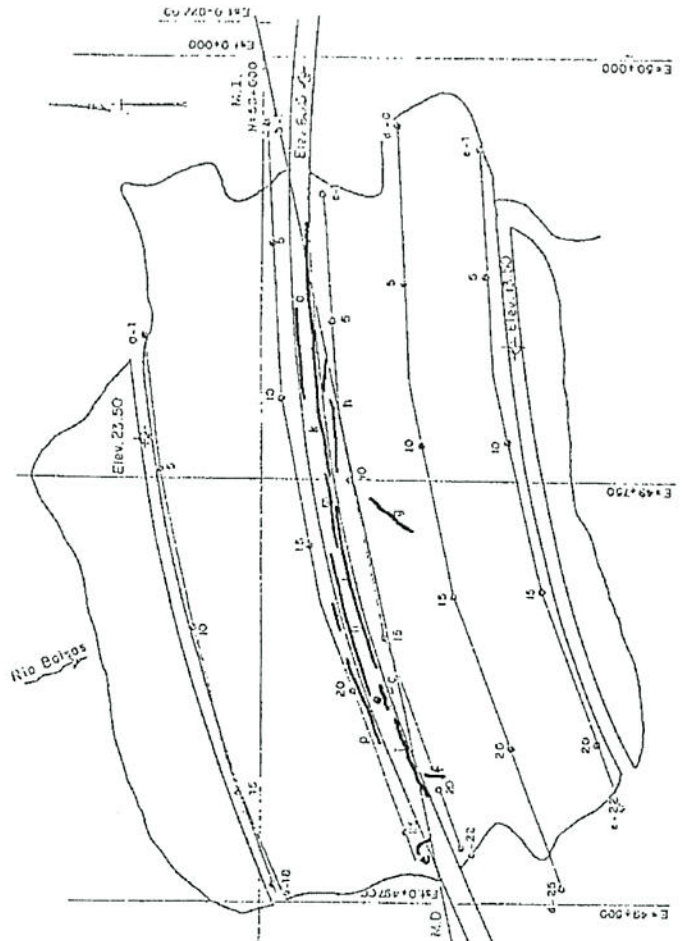
The dam suffered minor to moderate damage from this earthquake. Damage included cracking, settlement and spreading (ICOLD, 1999). Maximum **settlement** of 320 mm was recorded on the center of upstream side, and 220 mm on the center of the downstream. There were only small settlements adjacent to abutments. **Spreading** of the base resulted in horizontal movements of 100 mm and 165 mm for the downstream and upstream toes respectively. Two main systems of **longitudinal cracks** developed within 5 m of the crest on either side, including one up to 50 mm wide, 1.5m deep and 80m long on the upstream side and another 15 mm wide and 300 m long on the downstream side. The crack on the upstream side also featured a scarp of 15-50mm. Additional minor longitudinal cracks of 50 mm width were also found. Some transverse cracking was found adjacent to the right abutment. The cracking details for this event are depicted in figure 6. ICOLD (1999) report a crest **horizontal displacement** of 55 mm.

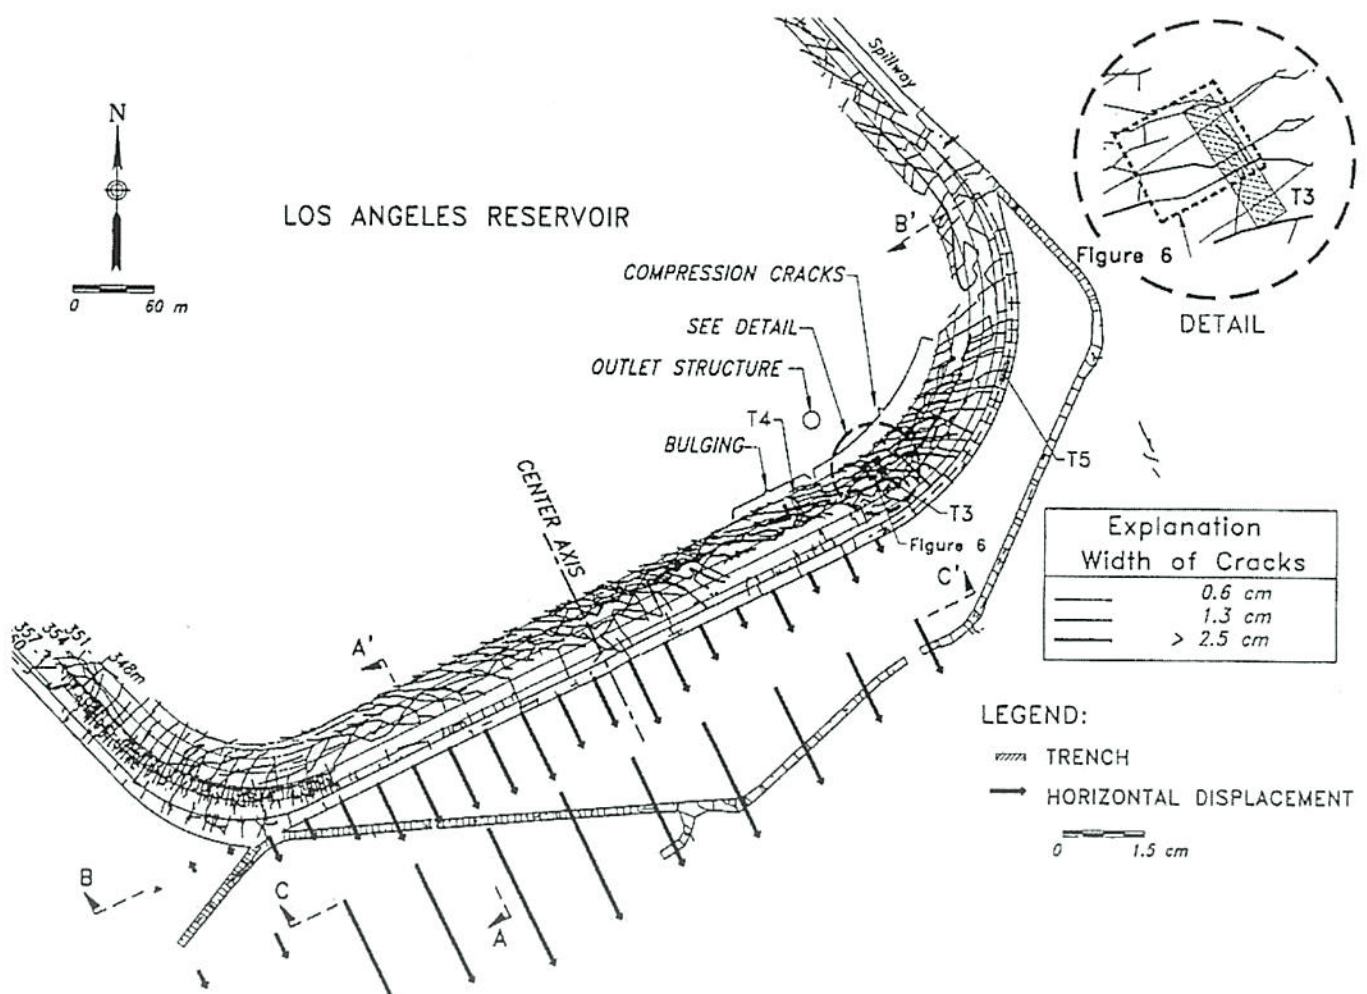
Settlements measured at the site had to be corrected to account for these large scale movements. Figure (KXXX) shows the profile of crest settlements at Los Angeles Dam. The 'corrected' figures are those which take into account large scale tectonic movement that occurred over the whole site - i.e. these figures give an indication of crest settlement relative to the foundation bedrock. Authors agree that the maximum crest settlement for this embankment was about 90mm (0.19% of embankment height). (Fong and Bennet, 1995; Swaisgood, 1998; Bureau *et al* 1996). Swaisgood describes damage as 'moderate'. Davis and Bardet (1996) write that most movement took place during the earthquake, and there was very little additional movements in the subsequent months.

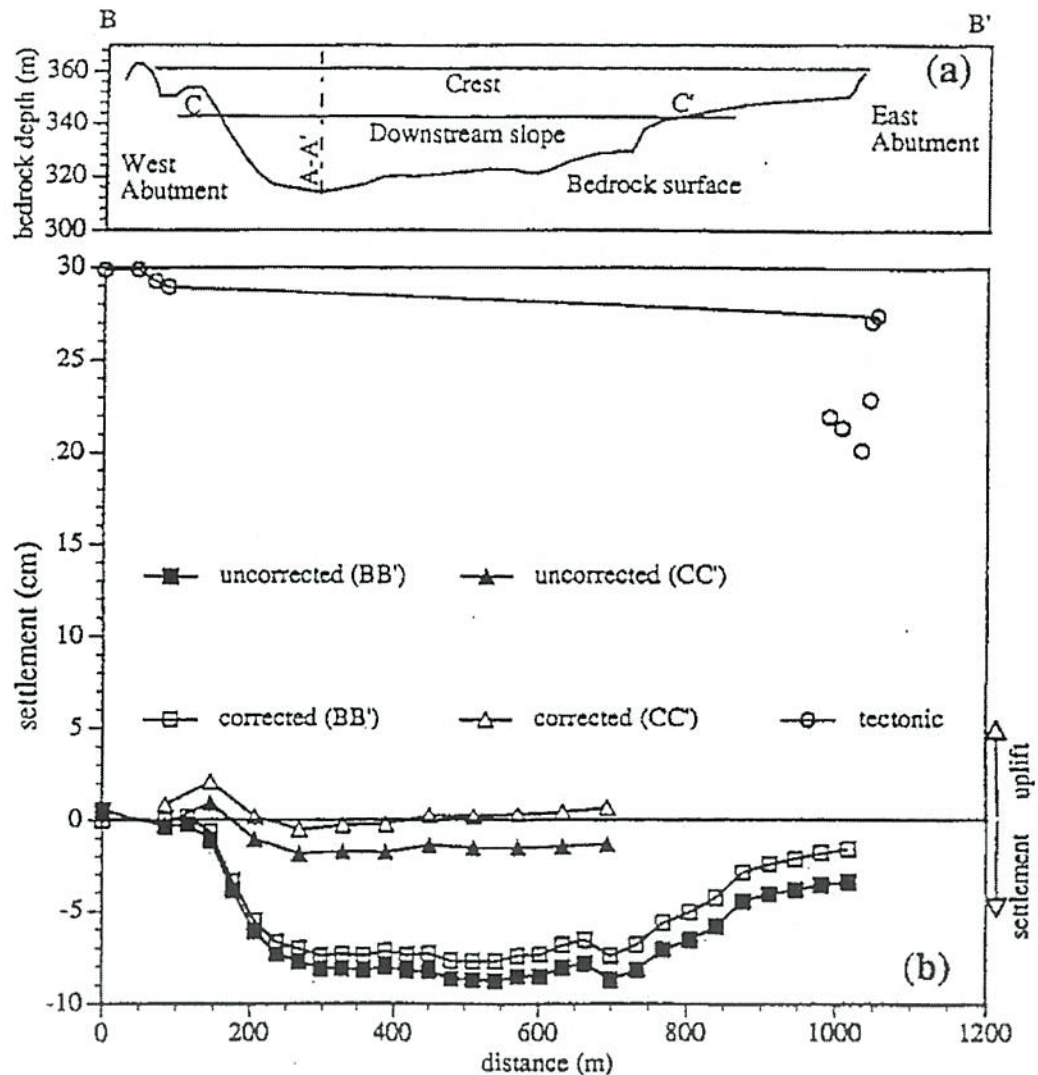
Authors agree that the cracking over the embankment was 'superficial', and trenching of the largest cracks indicated that even these did not extent into the dam body (ICOLD 1999). Fong and Bennett's (1995) record of the incident characterises the crack width as 1.3 mm.

Davis and Bardet (1996) write that the dense configuration of cracks on the asphalt face are not clearly related to permanent displacements and settlement. They suggest that these cracks may have been generated by transient stresses and deformations during the earthquake.

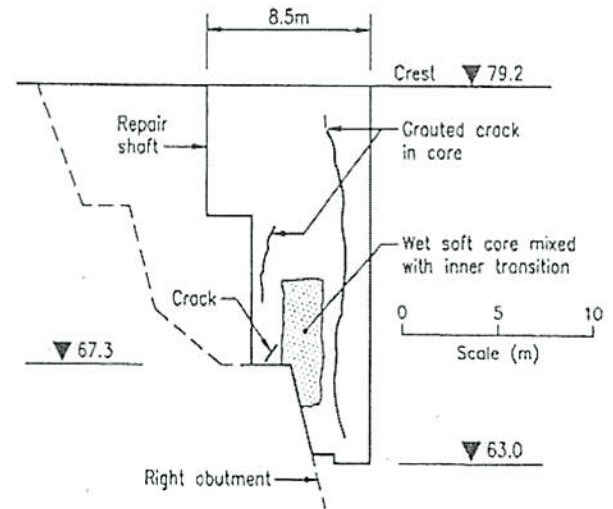
Figure 6

During first filling of the reservoir (in January 1967), an increase in seepage was noted. This seepage developed until, approximately two weeks later, an erosion cavity was detected near the right abutment. The lake was lowered and investigations revealed that the core had cracked adjacent to a 1.8m wide bench in the abutment, and that water had passed through, eroding as much as 100 cubic metres of transition materials. Investigations also found that erosion was being stemmed by inner transition materials being drawn into the crack.. The area was repaired by placing a plastic concrete patch behind the damaged core and by grouting the damaged core area with cement-bentonite. Later investigations (after the earthquake) showed that these repairs were not entirely effective (Gillon, 1997). The details of this event are depicted in Figure 6. The cause of the cracking was attributed, at least in part, to differential settlements being set up adjacent to the irregular abutment

1967 Right Abutment Core Damage

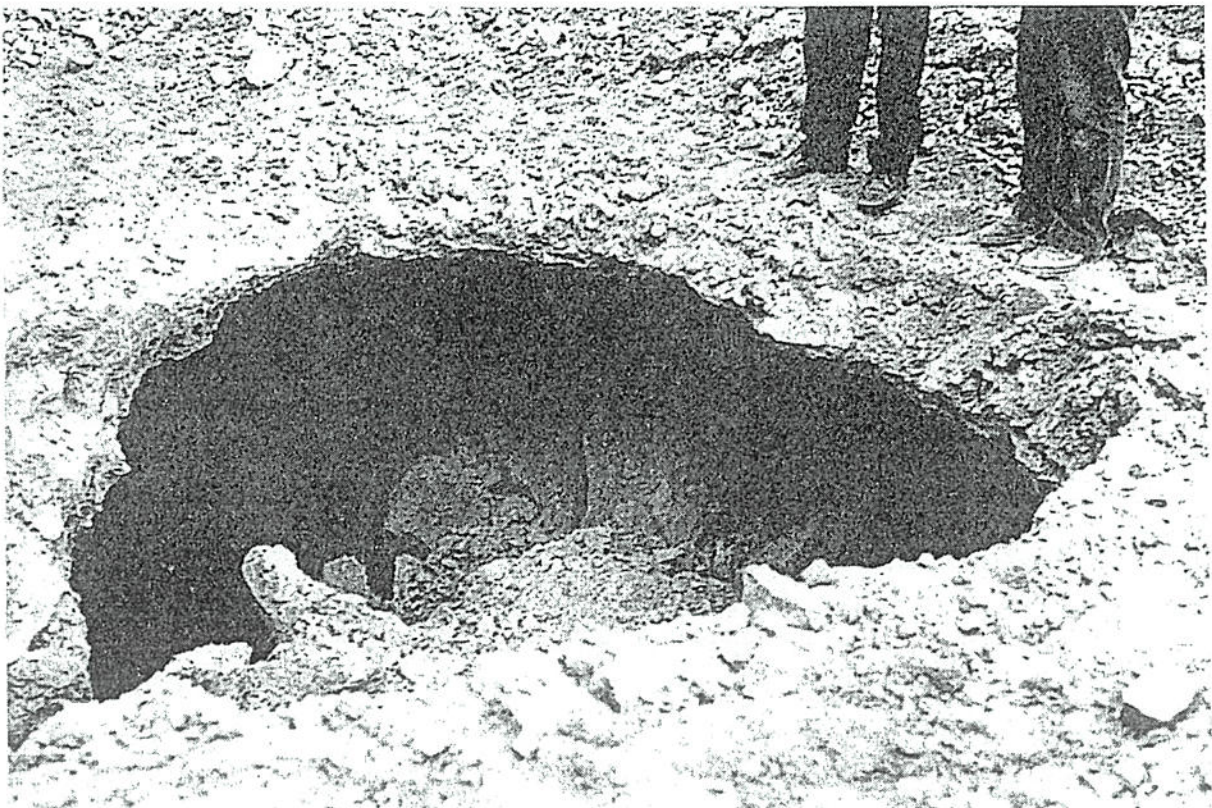
Figure 7 - Right Abutment incident during first filling

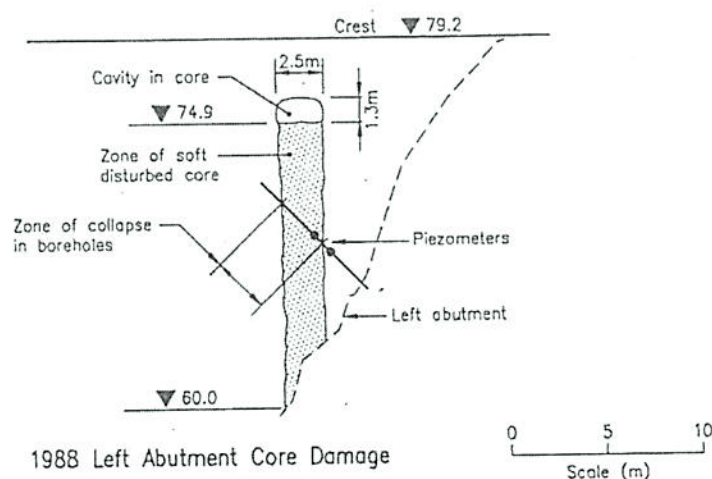
Figure 10

Inspections showed minor local settlements and surface **cracking** at the abutments. At the right abutment, investigations revealed some cracking through the abutment and embankment materials, and that some piping damage had been underway. However, the evidence for piping was attributed to the 1967 incident, not directly to the earthquake. Cracking in the core material adjacent to benches in the abutments were found at depths up to 29 m, although it is unsure whether these were a direct result of the earthquake (Gillon, 1997).

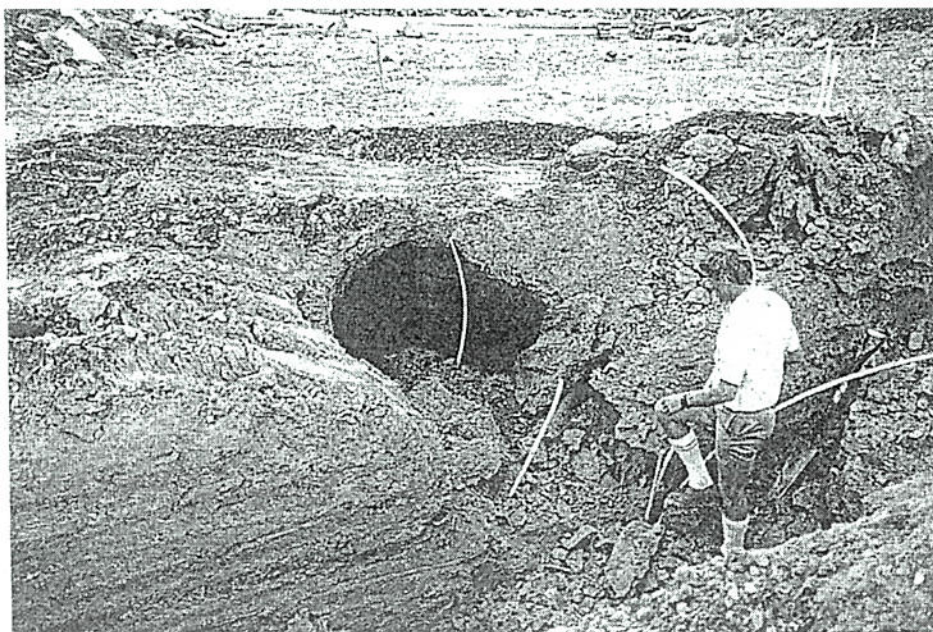
Investigations into the core at the left abutment found soft collapsing zones and piezometric levels close to lake level. However, as investigation proceeded into the left abutment (some 9 months after the earthquake), a cavity formed on the crest, above the downstream transition zone. The reservoir was drawn down and excavations found areas of significant piping induced erosion, featuring a 2.5m wide, 1.3m high cavity in the core zone. There was no evidence that self healing would have occurred and the downstream filter on the

left abutment was described as 'ineffective'. It was concluded minor cracking and settlement associated with the earthquake had reactivated semi-stable erosion damage that had existed since first filling. This had continued undetected for 10 months after the quake while other investigations were being performed. It is noted that the 2.5m draw down may well have prevented dam breaching (Gillon, 1997)

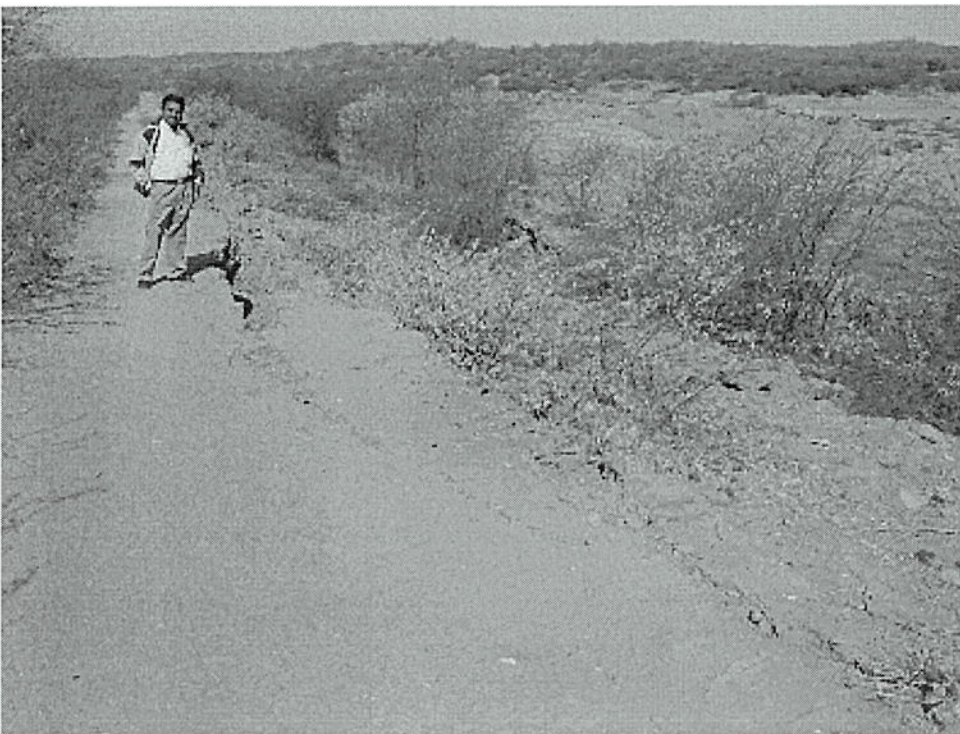
Longitudinal crest cracking was evidence of both upstream and downstream failures.

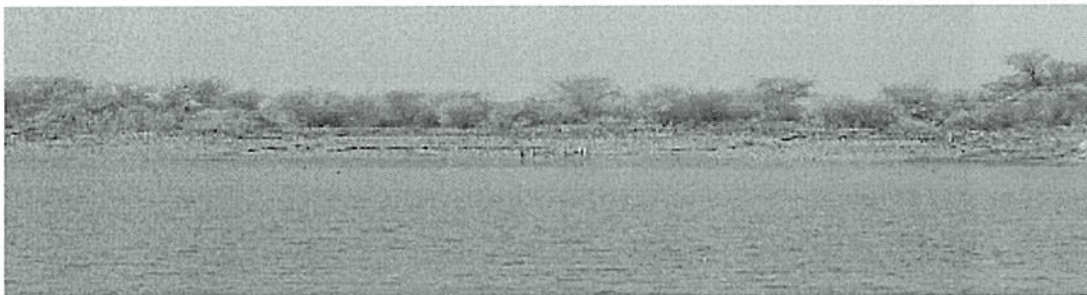
This dam experienced catastrophic failure of both the upstream and down stream faces with an overall crest drop of up to 10m. Chang Dam is located approximately 2km from observed tectonic ground deformations.

The large tree on the far right side of this picture is at the original crest elevation of the dam. Cracks can be seen along the entire length of the dam.

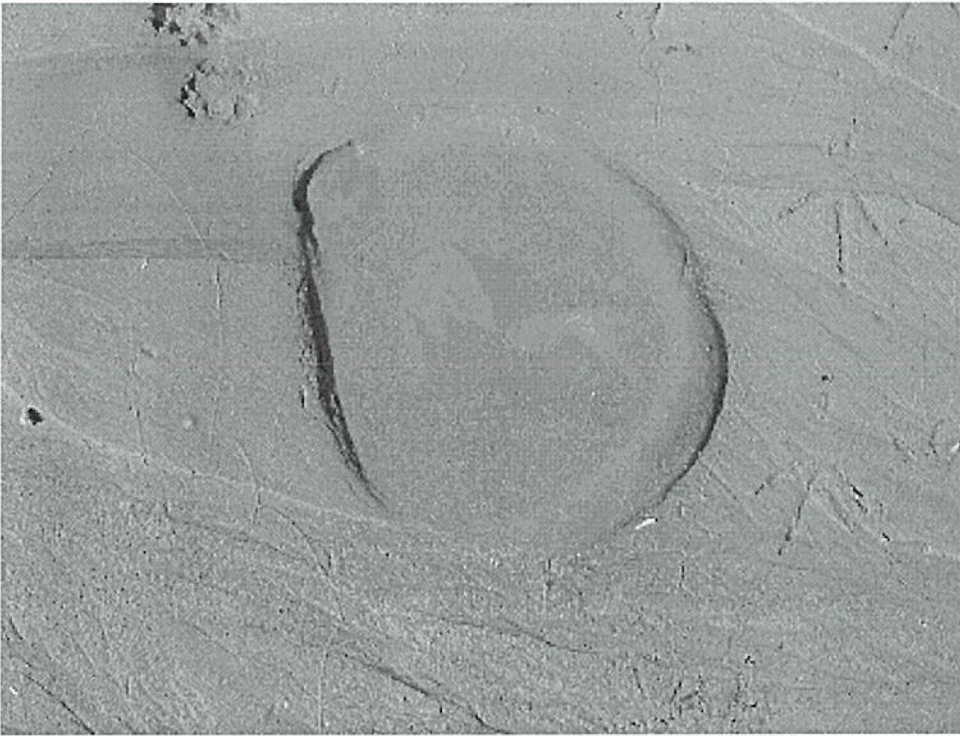
And the addition of a slight vibrational loading to the embedded rock results in further, more extensive, liquefaction.

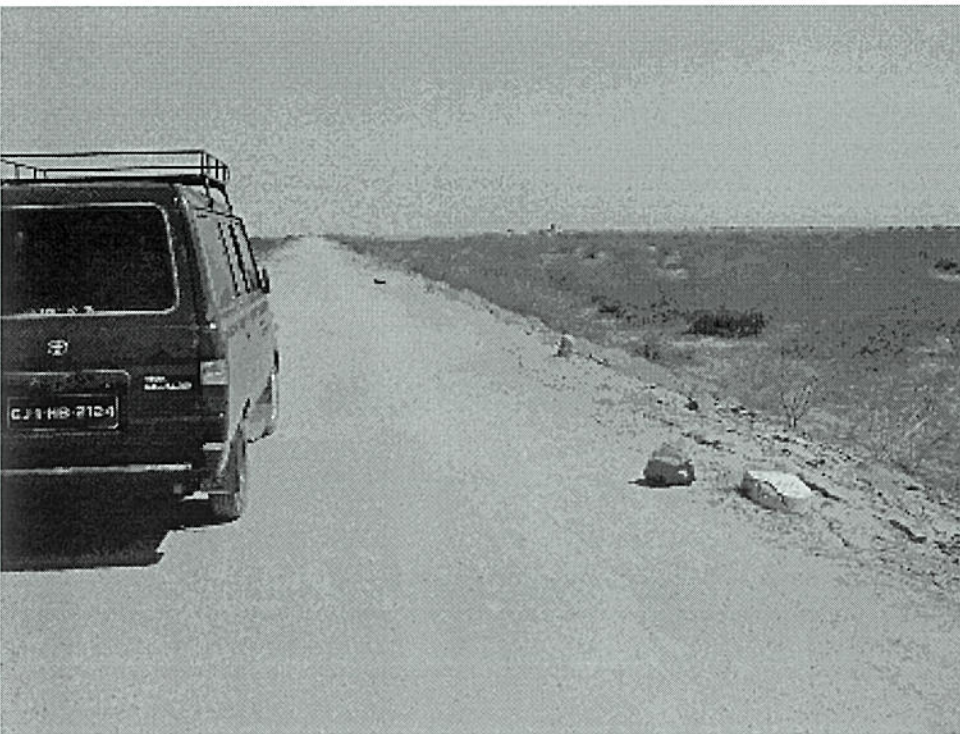
The observed damage and deformation occurred in conjunction with the location of these two stream channels.

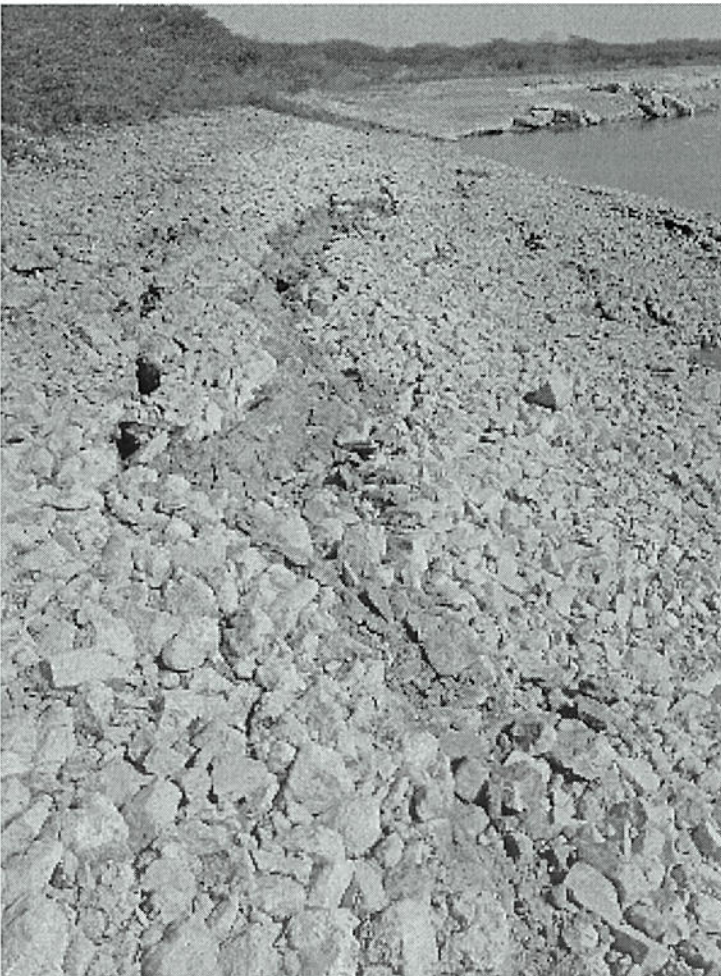
Cracking and slumping were observed along the upstream face. Scarps were up to 1.5m high with some evident rotation. Longitudinal cracks along the crest of the dam as well as toe bulges were observed.

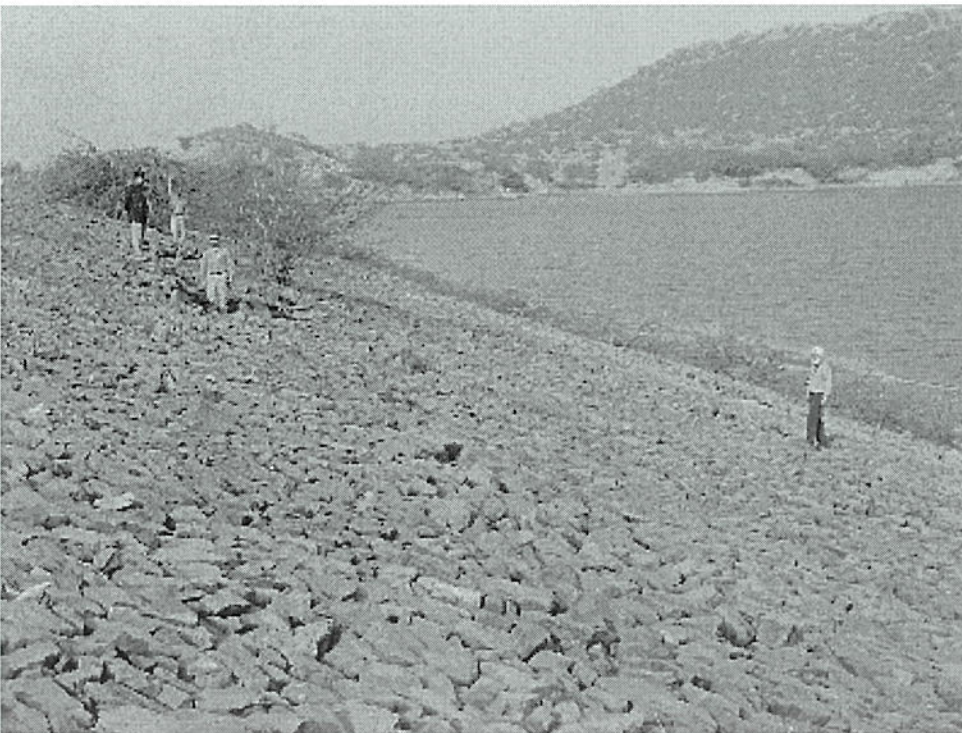
Complex failures occurred along the entire length of this dam, extending to the bedrock abutment.

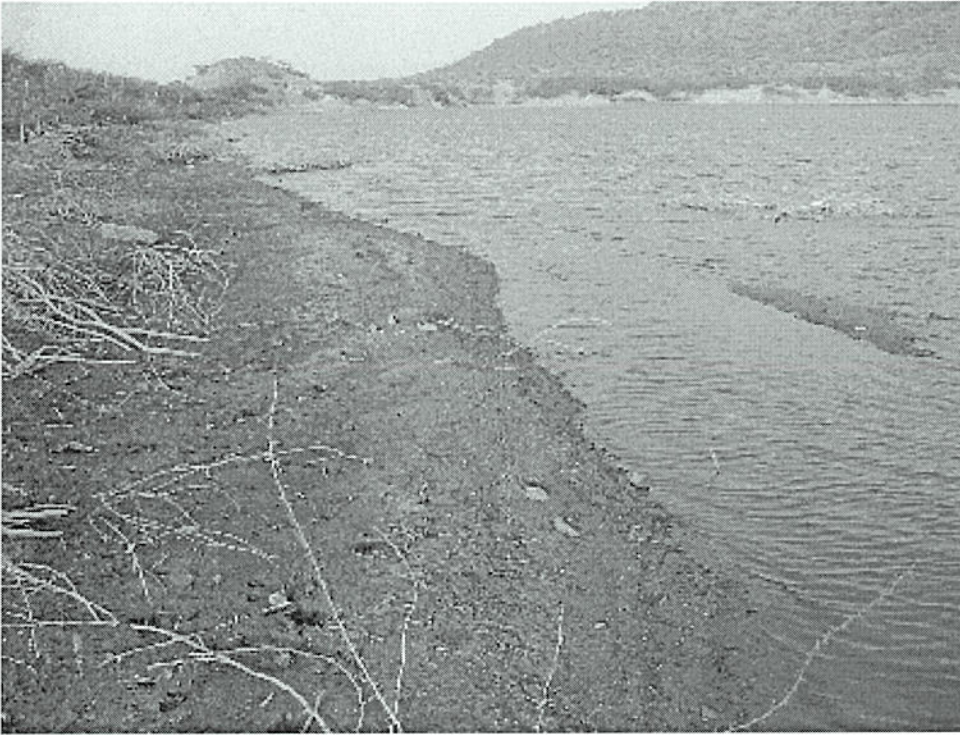
Toe bulging of silt and clay material.

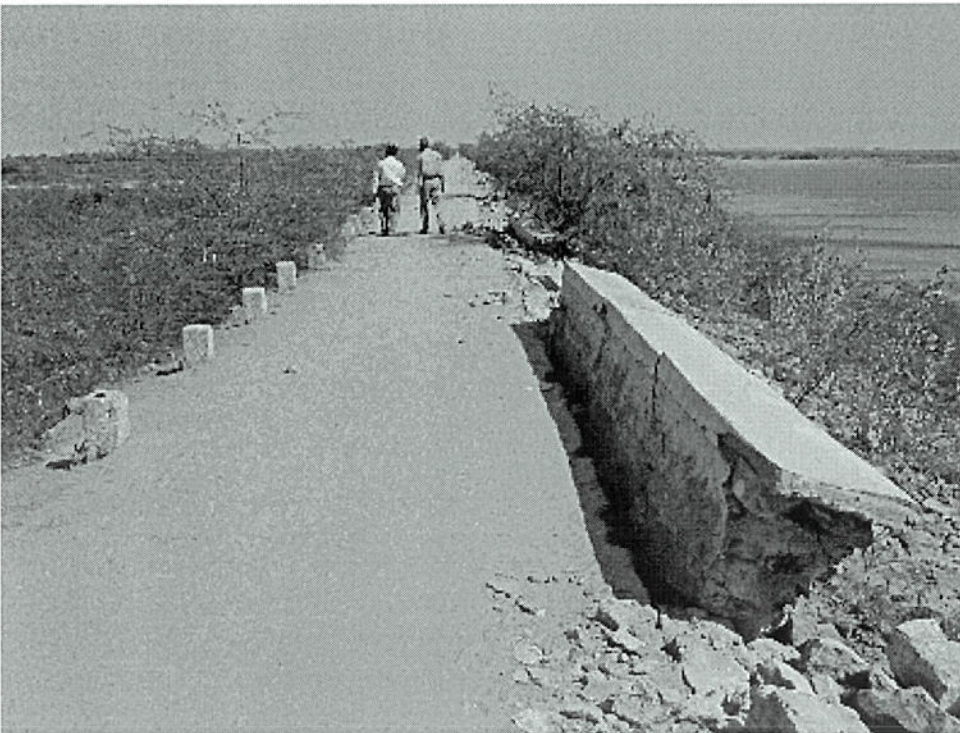
This 2.7km long dam had poor construction details. The crest was raised without a corresponding raise in the core, resulting in several meters of pervious material at the crest. A parapet wall was placed at the top but not tied into the core, resulting in a top section of the dam that could allow uncontrolled through-flow. The parapet wall was damaged along 60% of the dam length.
