**DAMAGE AND CRACKING OF  
EMBANKMENT DAMS BY EARTHQUAKES  
AND THE IMPLICATIONS FOR  
INTERNAL EROSION AND PIPING**

STEVEN PELLIS AND ROBIN FELL

UNICIV REPORT No. R-408 JANUARY 2002  
THE UNIVERSITY OF NEW SOUTH WALES  
SYDNEY 2052 AUSTRALIA  
<http://www.civeng.unsw.edu.au>

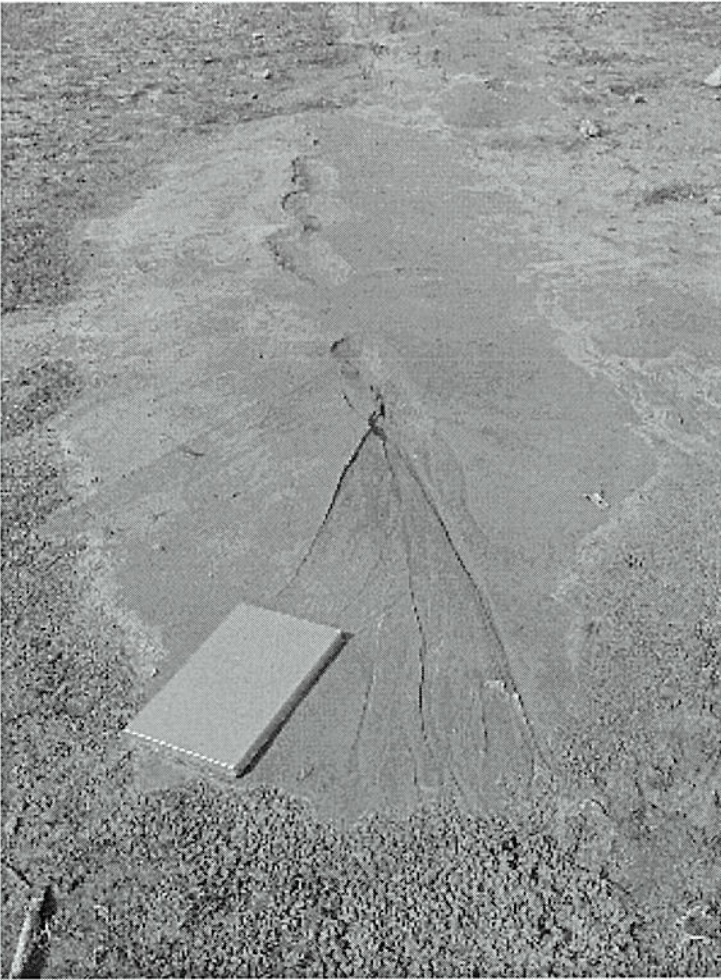
Extensive liquefaction along the upstream toe with ejecta consisting of silty sand. Sand boils also occurred downstream.

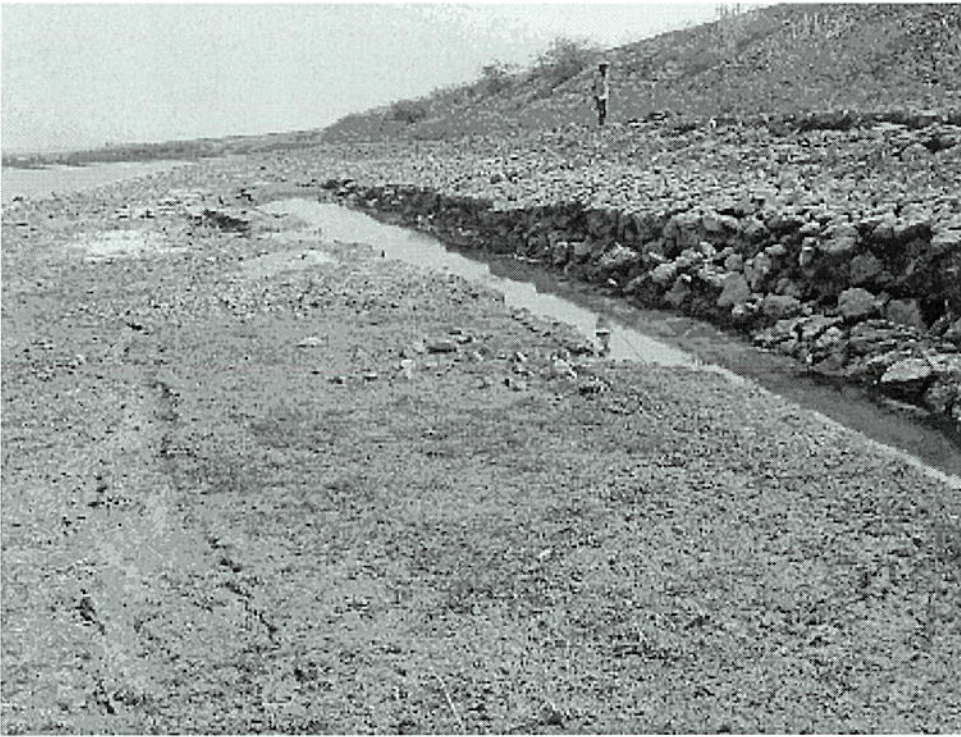
Lateral spreading resulting in a down-dropped section.
