ANALYSIS OF CONCRETE AND MASONRY DAM INCIDENTS

K J DOUGLAS, M SPANNAGLE and R FELL

**UNICIV REPORT No. R-373 AUGUST 1998
THE UNIVERSITY OF NEW SOUTH WALES
SYDNEY 2052 AUSTRALIA**

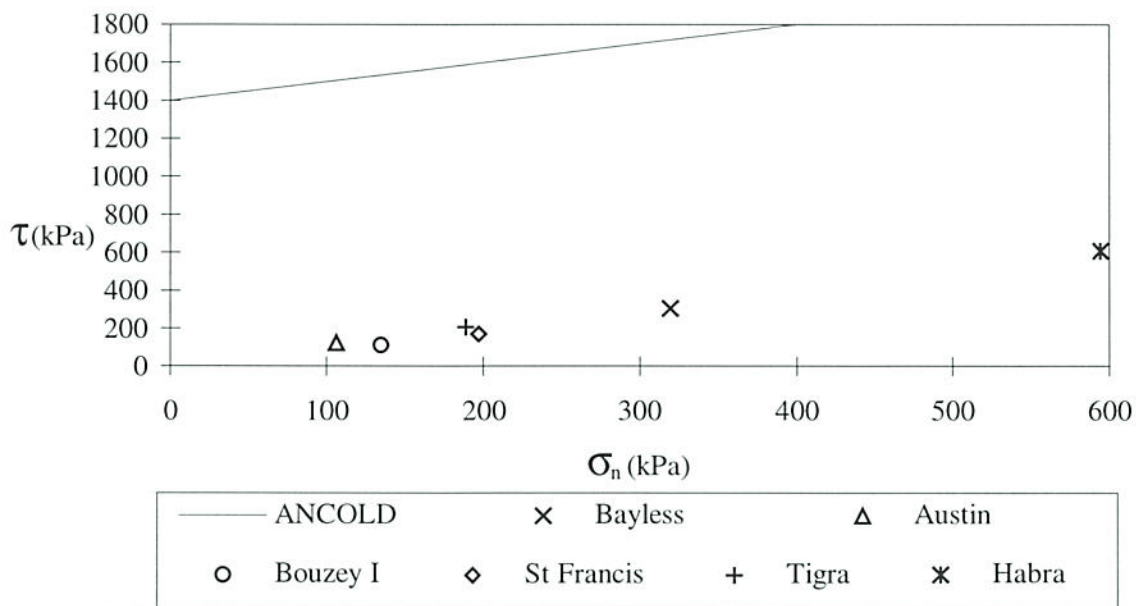
Figure 41. Average Failure Stresses for Dams with Failure through the Foundation

The average stresses acting along the failure planes have been calculated using the forces on each dam provided by Rich (1995). Figures 41 and 42 compare the ANCOLD guidelines (ANCOLD, 1991) to the failure stresses of the nine failure cases. It was assumed that shear strength only acted in the region of compression along the failure plane. The figures show that the failure stresses were much lower than those recommended by ANCOLD for initial assessments. The likely reason for this is the existence of continuous defects through or below the dam. The friction angle and cohesion suggested by ANCOLD assumes no continuous defects. The results show the importance of having a good geotechnical model for the dam and a good bond at the dam/foundation interface.

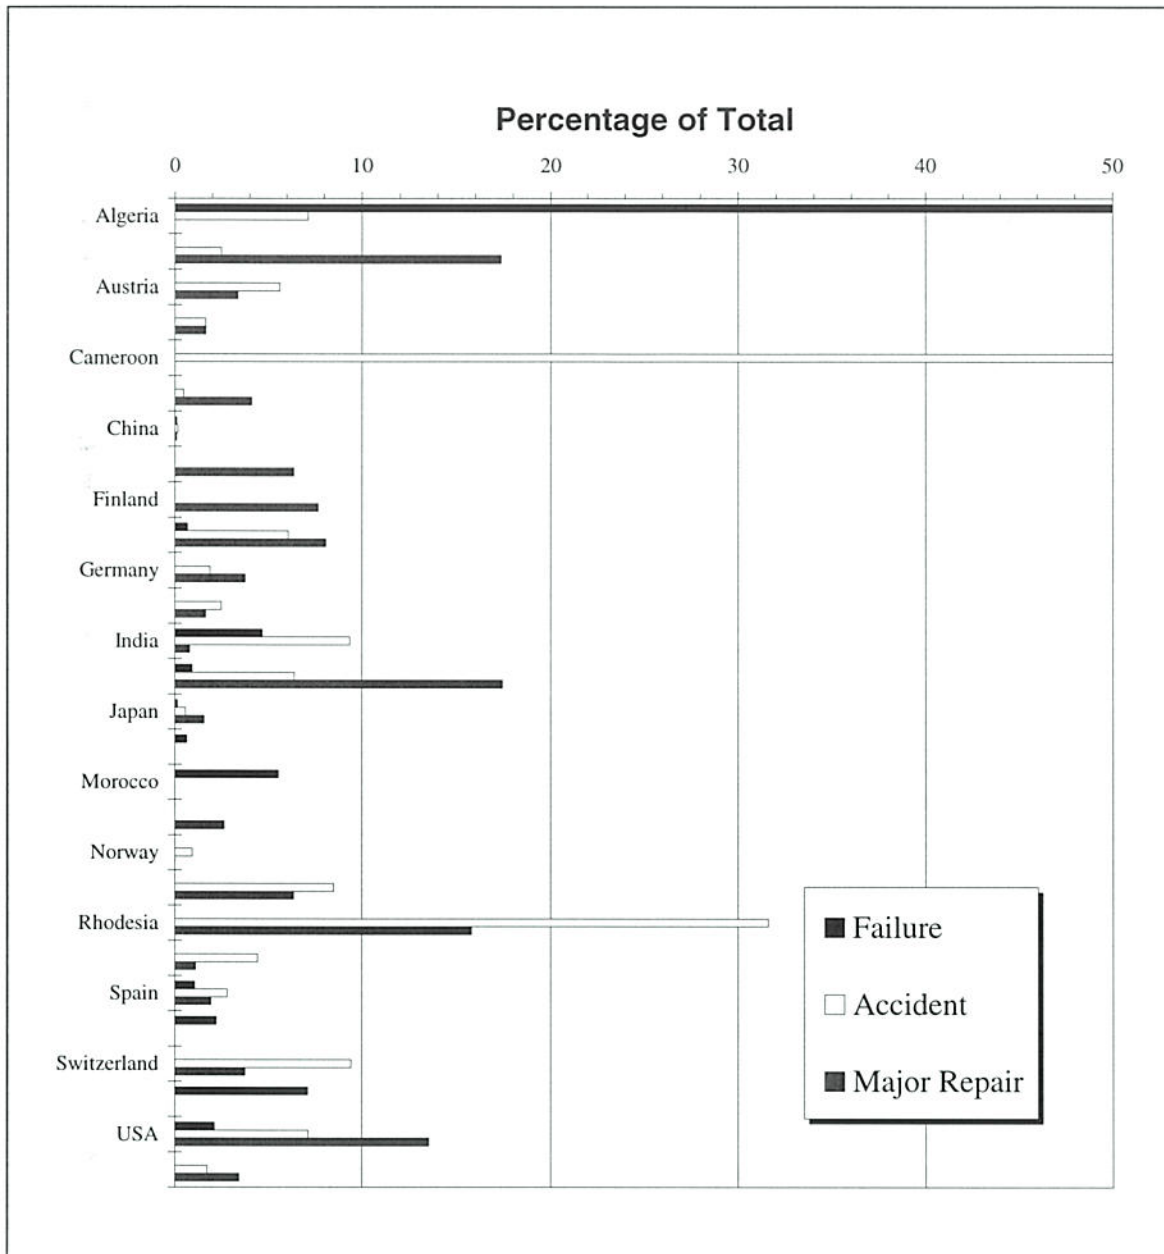
Figure 4. Reported Incidents as Percentage of Country's Dam Population from ICOLD (1984)

Figure 4 shows the dam incidents as a percentage of the total population of dams in each country. Algeria shows a large proportion of failures to their dams. Appendix J shows the population of dams in each country as given by ICOLD (1984). The population in Algeria was taken as 14 (those in existence in 1983 plus those that failed). Due to their small populations Morocco and Turkey show high percentages of failures. India (5%) is noticeable particularly for its larger population. The USA has a failure rate of approximately 2%.

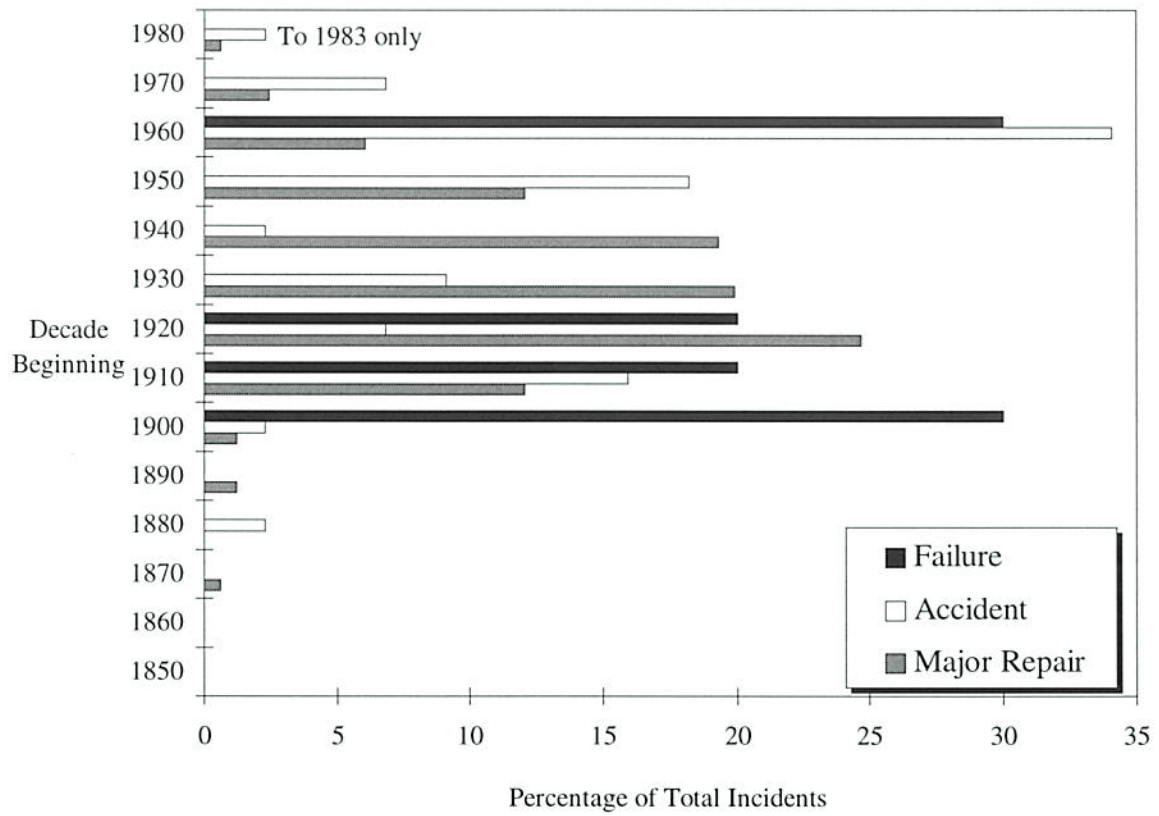
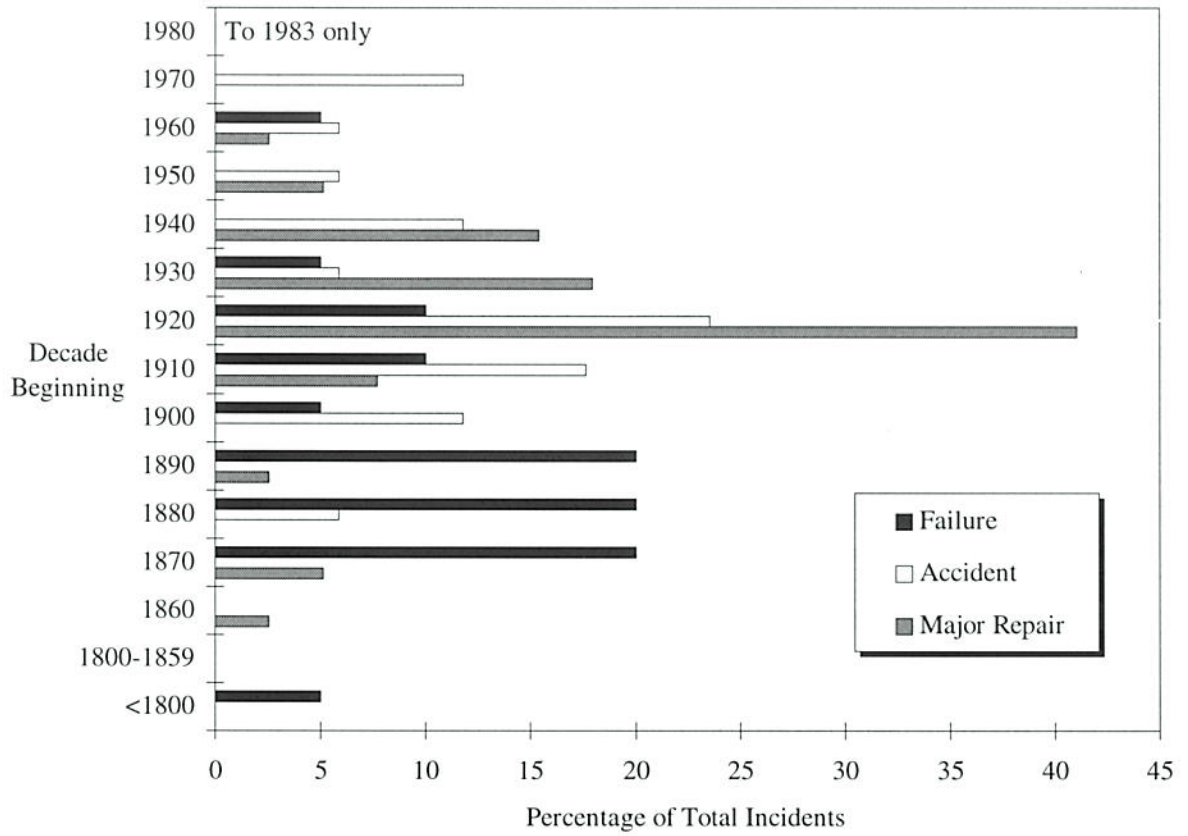
Figures 5 and 6 show the year dams were commissioned (broken into decades) for concrete gravity dam and masonry gravity dam incidents respectively. There were a total of 10 failures, 44 accidents and 165 major repairs for concrete gravity dams and 21 failures, 17 accidents and 39 major repairs for masonry gravity dams. Due to their age, it is considered likely that masonry gravity dam accidents and major repairs are less likely to have been reported to ICOLD.

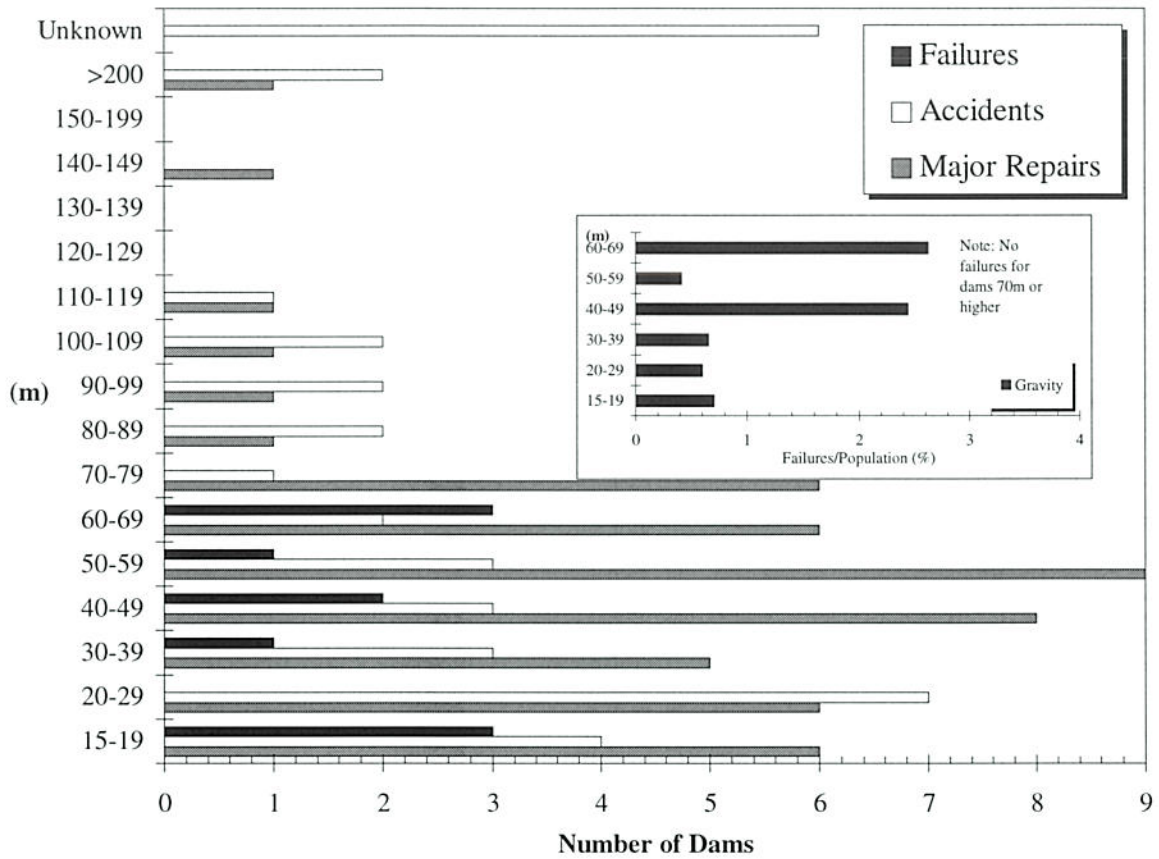
Figures 12 and 13 show the height versus number of dams for significant incidents in concrete gravity and masonry gravity dams respectively. Proportionally more failures, accidents and major repairs have occurred in higher dams for concrete gravity dams than masonry gravity dams but this may simply reflect the fact that there are fewer high masonry gravity dams.

There were no accidents reported in the range 120-199m for concrete gravity dams. No incidents were reported for masonry gravity dams higher than 100m.

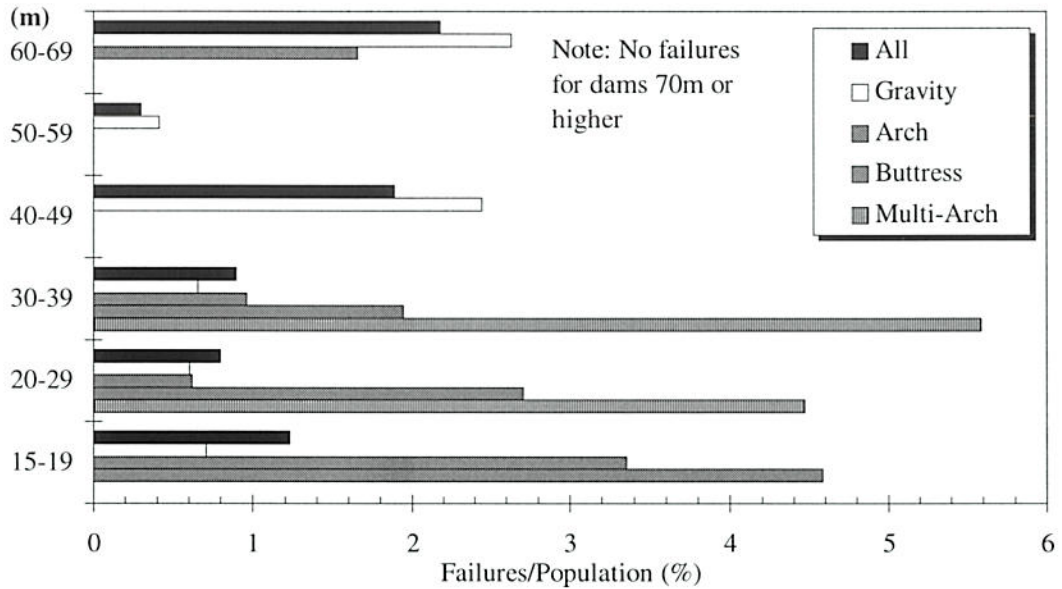
Figure 14. Height of Failed Dams - Failures/Population (%)

Tables 12 and 13 and Figure 14 show the percentage of failures and accidents of concrete and masonry dams as a percentage of the population created from ICOLD (1979 and 1984). The database was created from the ICOLD (1979) dam population and extrapolated to the population in ICOLD (1984).

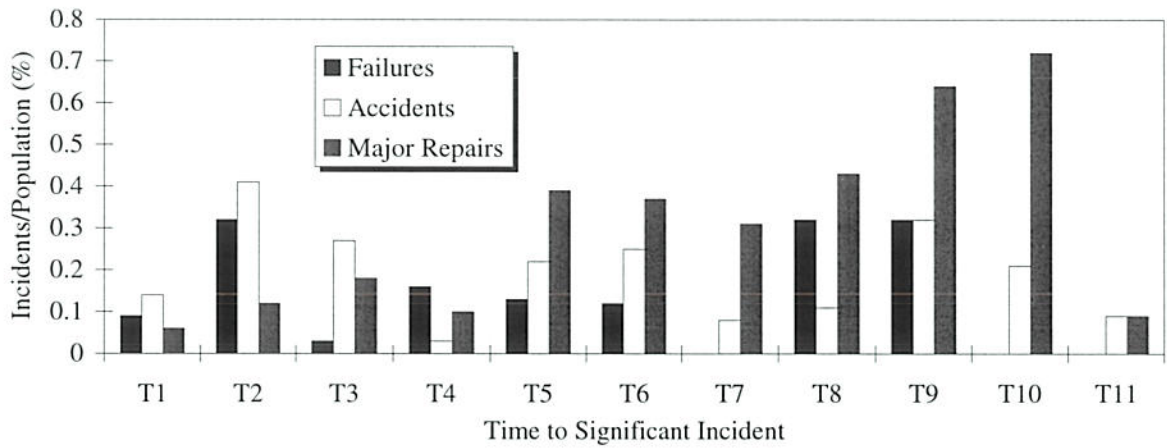
Figures 19 and 20 and Table 16 show the time to significant incidents for dams. The data is presented as the number of incidents in a time period divided by the population of dams that had survived that time period. The population was taken from ICOLD (1979) and extrapolated to 1983 dam numbers.

First filling is still the predominant failure time. There appears to be a slight rise in the rate of failures with time (ignoring T2). After 40 years of age there is a jump in the failure rate. It should be noted that the older age groups are represented by a small population.

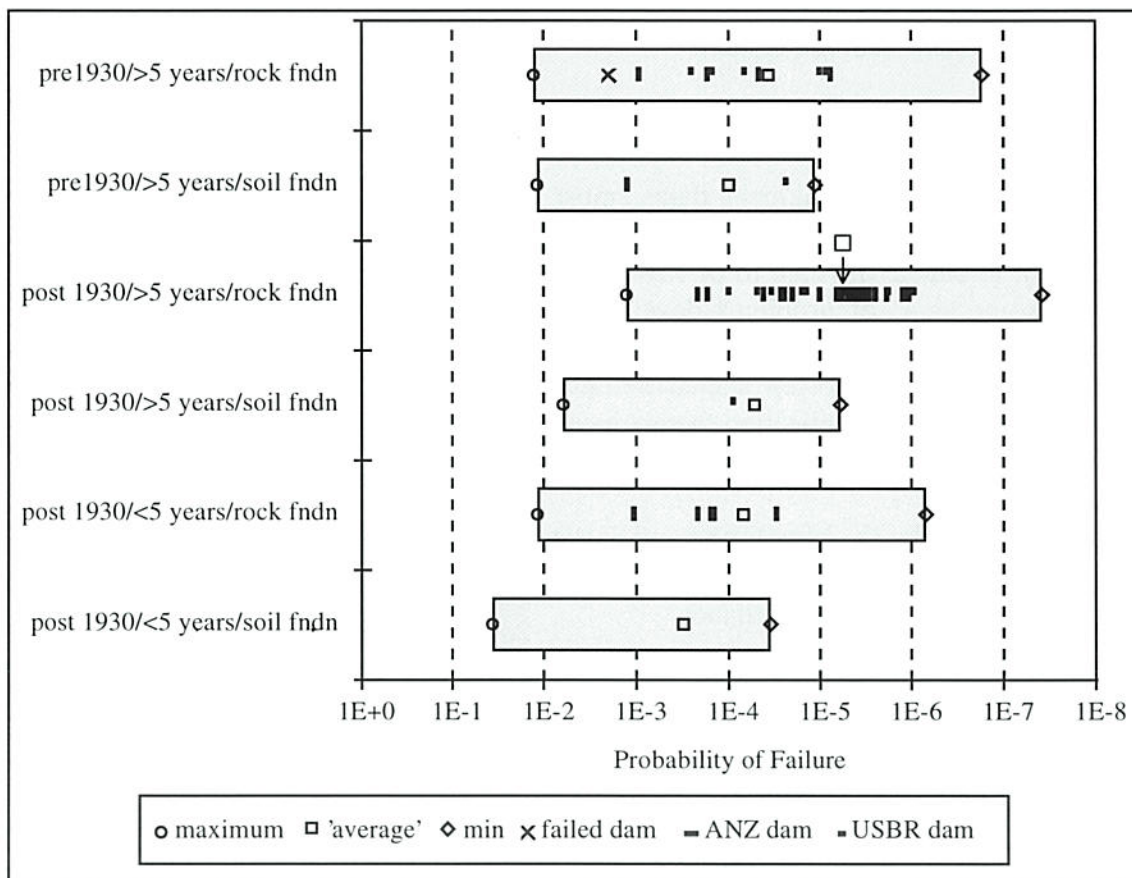
Figure 46. Range of Annual Probability of Failure for Concrete Gravity Dams

Figures 1 and 2 show the potential ranges for the annual probabilities of failure for various cases. The ‘average’ dam has been taken as a dam that has: a geology type factor, f_{SG} , of 0.9; a height to width ratio, h_d/W , of 1.3; and the remaining multiplication factors as unity. A number of dams that have failed have been plotted together with dams from the Australia/New Zealand population and USBR population of concrete and masonry gravity dams. None of the dams plotted have the f_{red} reduction factor, as it could not be proven that they satisfied the criteria described above. Where unknown, multiplication factors were taken as their default or unity. For the most common type of dam (commissioned after 1930, greater than five years in age and on a rock foundation) the potential average probabilities using the method range from 4×10^{-8} to 1×10^{-3} .
